MINUTES OF THE STATE CONSERVATION COMMISSION

February 1, 2021

Woody Revetment Monitoring in the Upper Lower Smoky River Watershed – 2020 Final Report

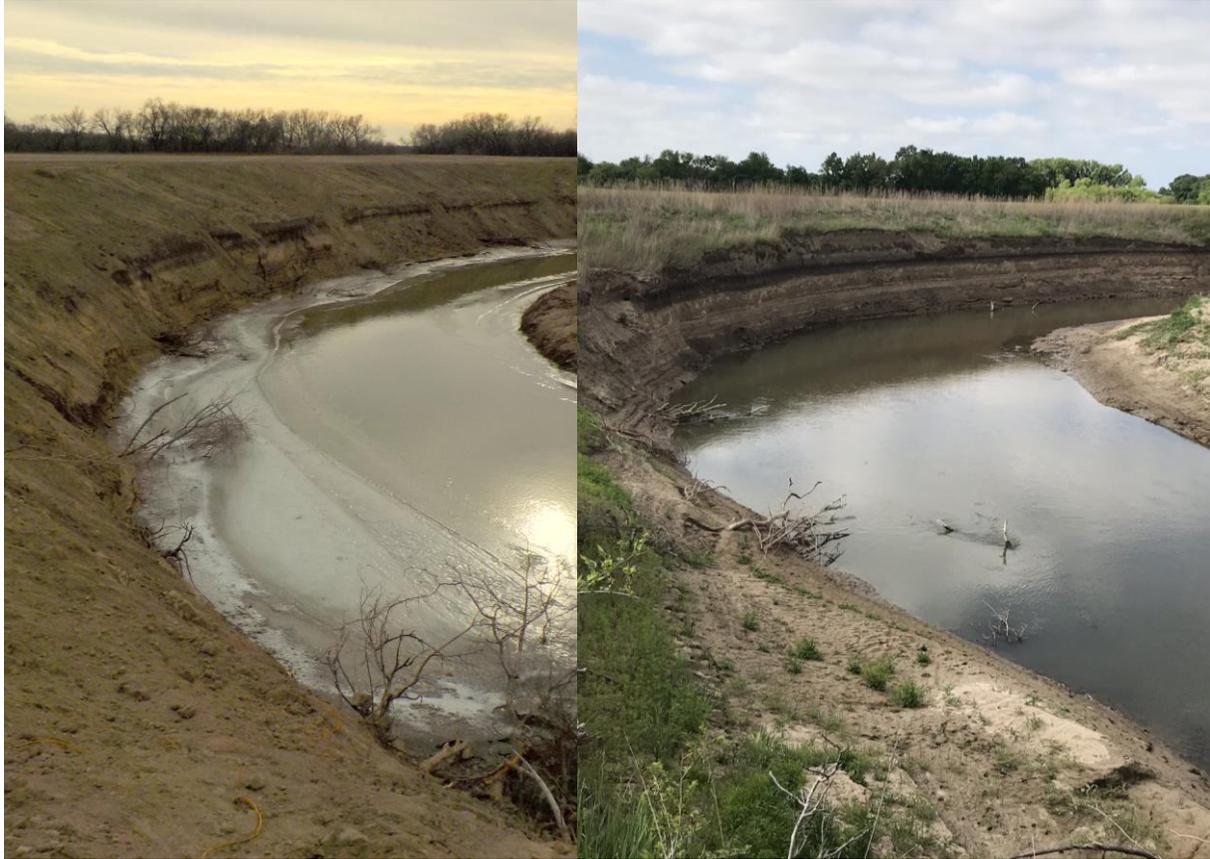
Site 20 – January 12, 2017 (left) and May 19, 2020 (right)

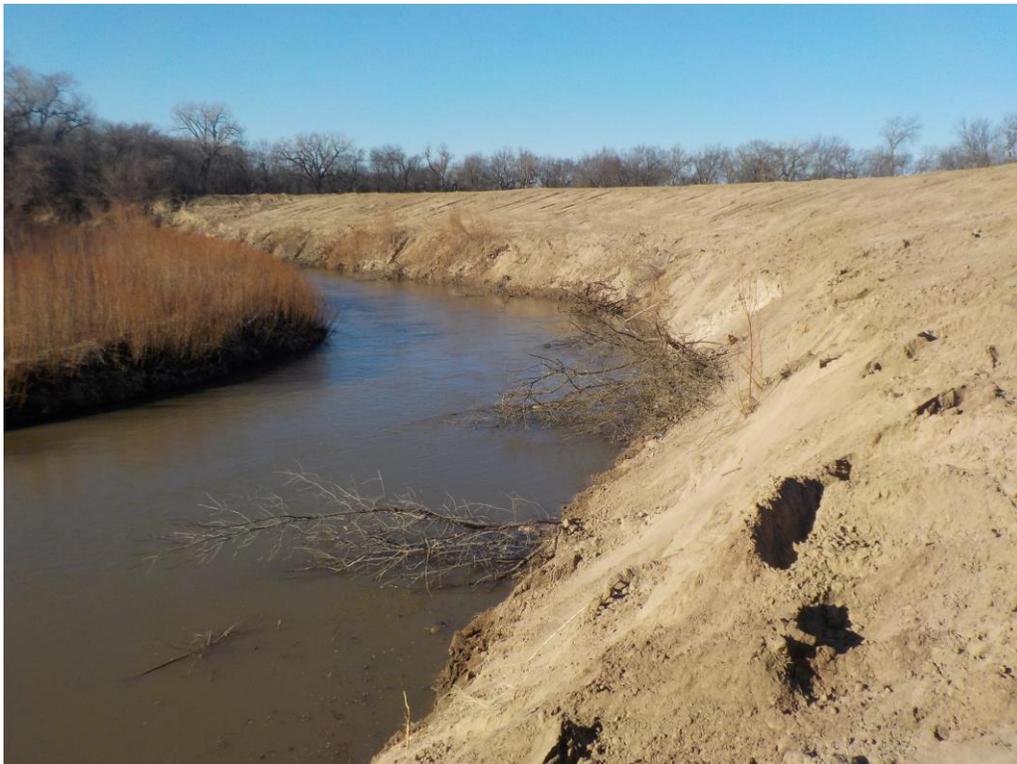
Figure 1. Example of Woody Revetments and Bank Shaping following construction on the Smoky Hill River, Kansas (Site 27, January 2017).

The purpose of this monitoring study was to evaluate the short-term effectiveness of woody revetments using deciduous trees, in conjunction with bank shaping (Figure 1), in stabilizing eroding streambanks on reaches of the Smoky Hill River located in central Kansas. Changes in water quality conditions and macroinvertebrate habitat were also assessed.

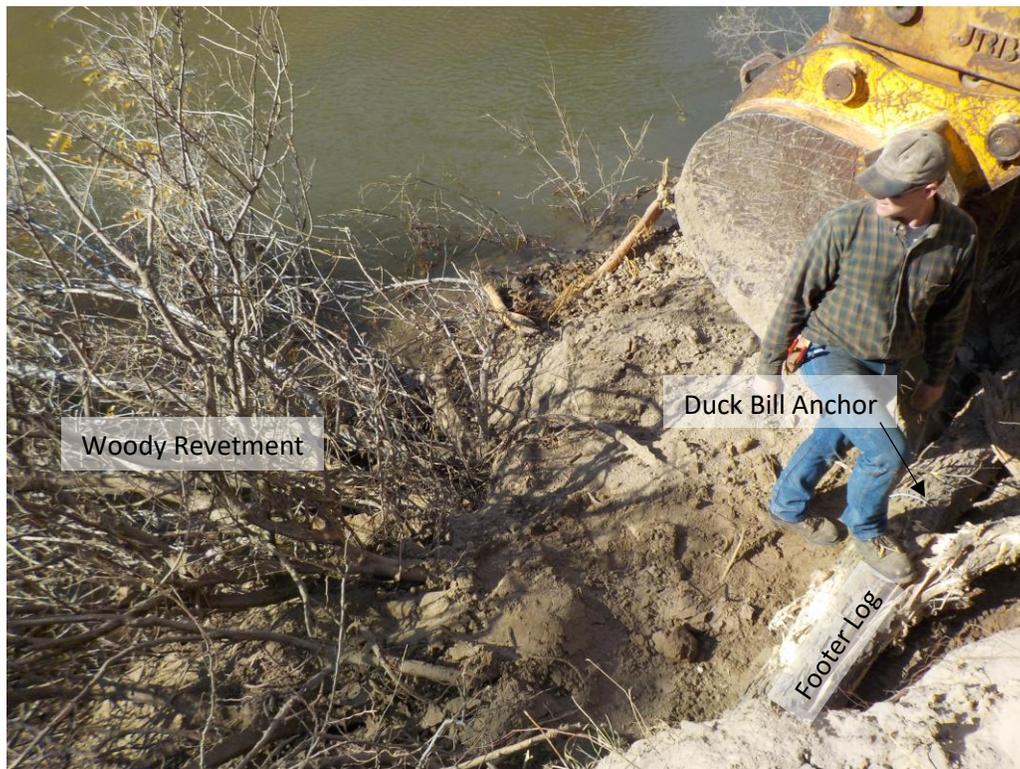
Figure 3. Woody Revetment Installation on the Lower Smoky Hill River, Kansas.

Woody revetment design, completed by an outside engineering consulting firm, was loosely based on a field observation of bank erosion-induced large wood recruitment that created a low bench near the streambank toe on the Lower Smoky Hill River. Woody revetments designs called for a single deciduous tree, roughly one-third of the bankfull width long and a diameter at breast height of about 12 inches, angled downstream at 30 degrees from the bank tangent line and placed with the root wad buried 10 feet into the streambank toe. In addition to keying the tree into the streambank, a 12-inch diameter by 10-foot long footer log was placed on top of the root wad and perpendicular to the woody revetment. The footer log was secured by placing a 5-foot cable around the tree and driving it into the streambank with a 3-inch duckbill anchor (Figure 3). The root wad and footer log were then buried in a series of compacted soil lifts. Exposed lengths of woody revetments were designed to be 0.2 times the bankfull width with spacing of three times the exposed length. In cases where streambank shaping occurred, a minimum slope of 2H:1V was utilized starting near the bankfull elevation. Woody revetments consisted of mainly walnut, hedge with a few ash, elm, and hackberry logs while footer logs were all hackberry. Mulberry was tested as a woody revetment log but had to be replaced after significant beaver damage occurred immediately following installation.

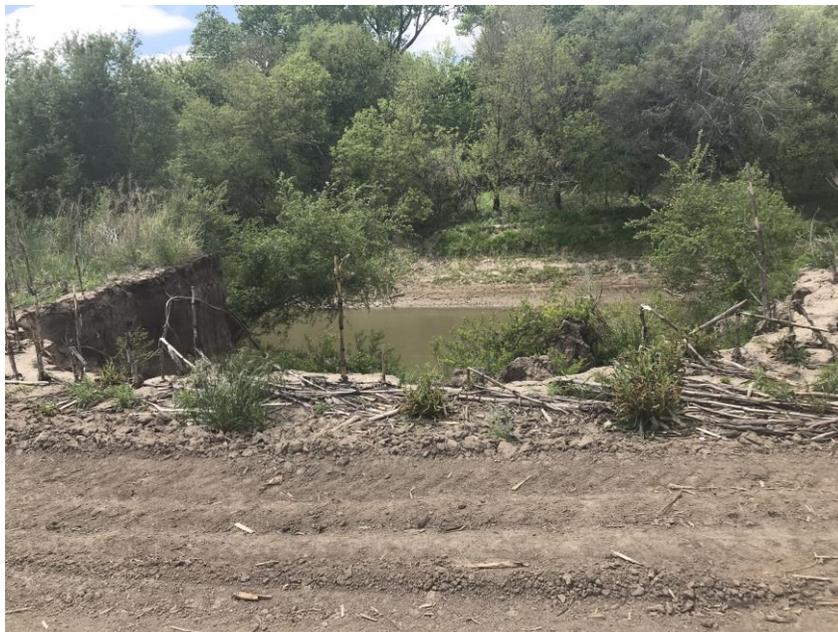
Figure 8. Bank Slumping on Site 22 (Reach 4) in Region of Woody Revetment Installation, May 2020.
