# KANSAS DAMS

2014

## OPERATION & MAINTENANCE

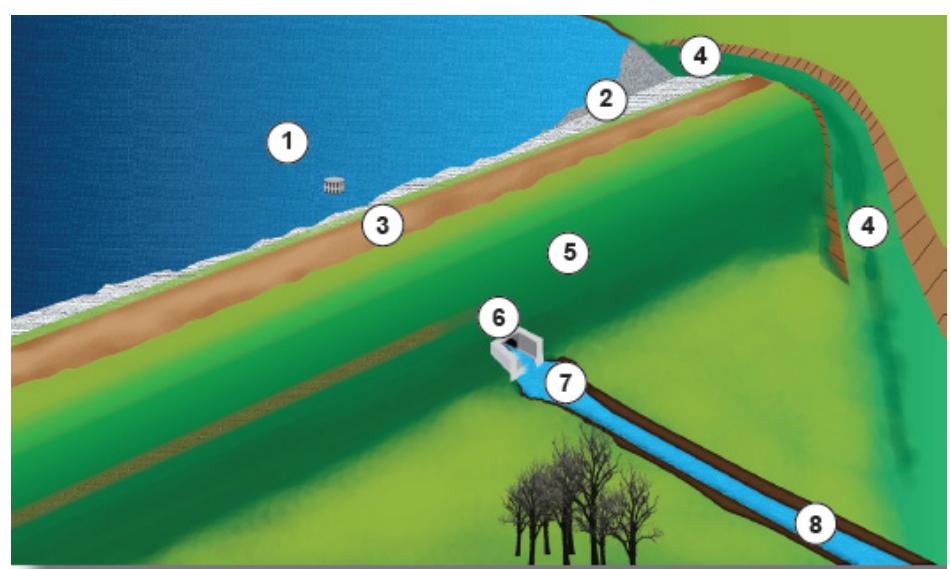
**Note:** Individual dams vary in design and not all dams have the same features.

1. Intake Structure and Reservoir

Image courtesy of Nebraska Department of Natural Resources

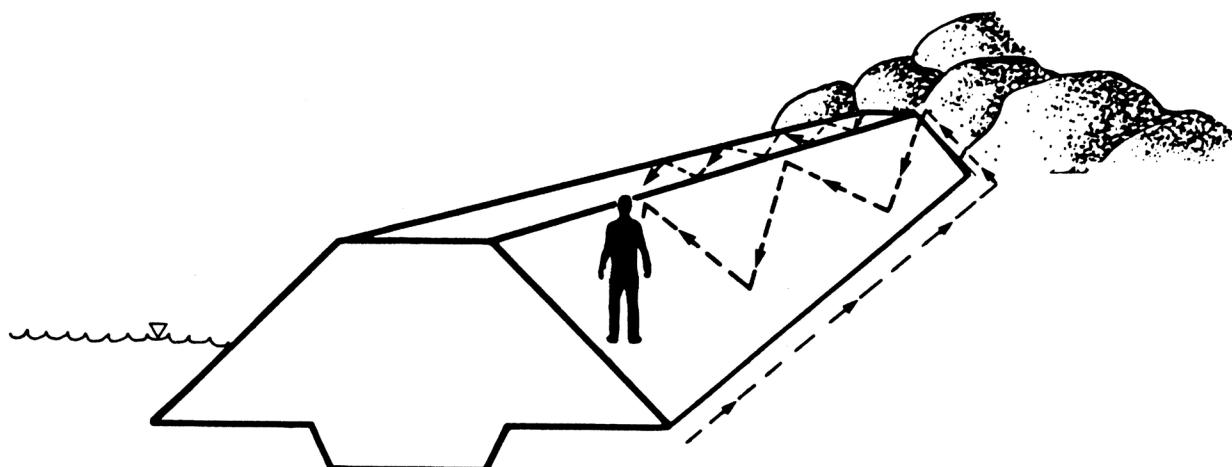
A zig-zag inspection path is recommended to more easily identify structural problems.

Experienced dam inspectors recommend walking across the crest from abutment to abutment, walking across the slope in an up-and-down or zigzag pattern from abutment to abutment, and walking the entire length of the embankment-abutment contacts (groat).

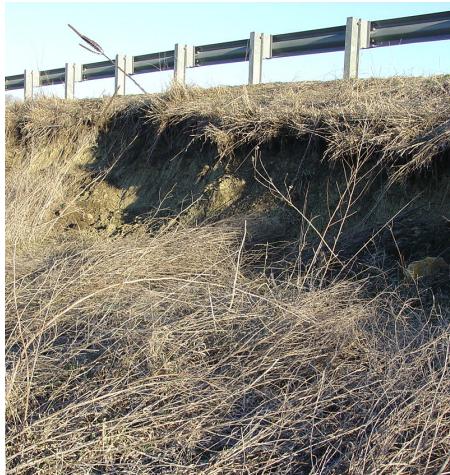
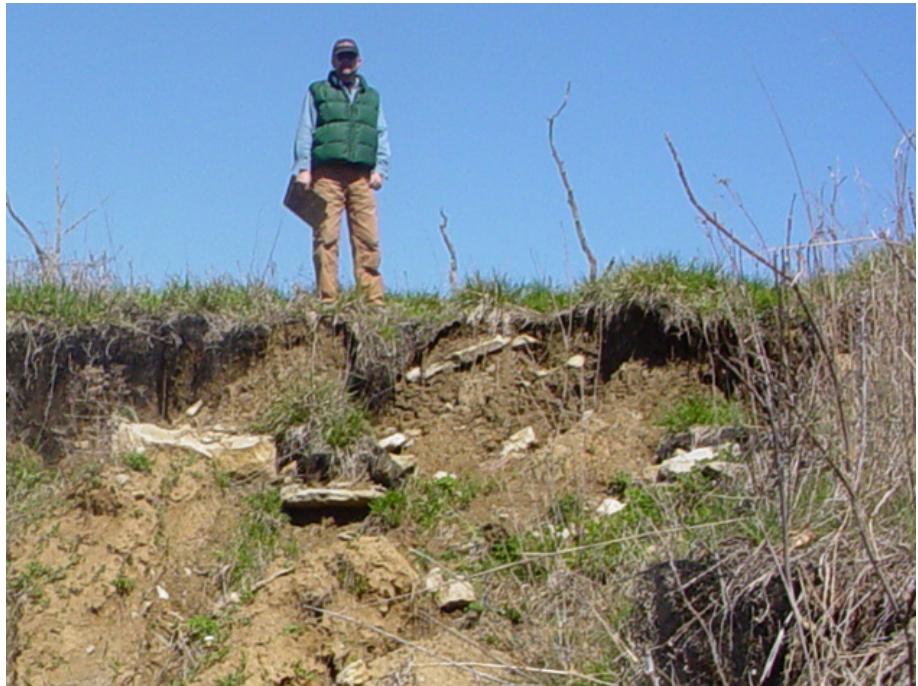
DWR dam inspectors note the slide condition and take measurements as seen in these photographs. When inspecting, evaluate slide extent, monitor slide, draw down the reservoir level if dam threatened, and have qualified engineer inspect the conditions and recommend further actions.

Two forces act upon soil mass: the driving force of soil weight and gravity that tends to move soil mass downward. Resisting gravity is the slope's material strength and cohesiveness that holds soil mass in place.

If the driving force is greater than the resisting force, a soil mass will slide along the slip surface and a slope stability failure will occur.

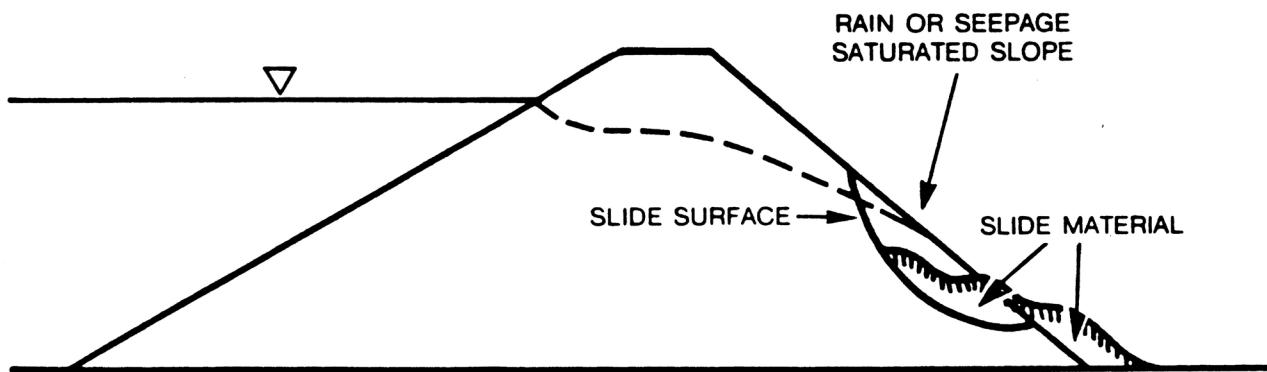
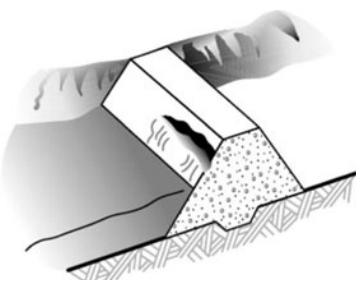
Fill compaction can be a factor in slope failure. A dam should be built with compacted soil that is added in layers, and then compacted before adding another soil layer for optimum stability. *Photo below and left from Leavenworth County.*

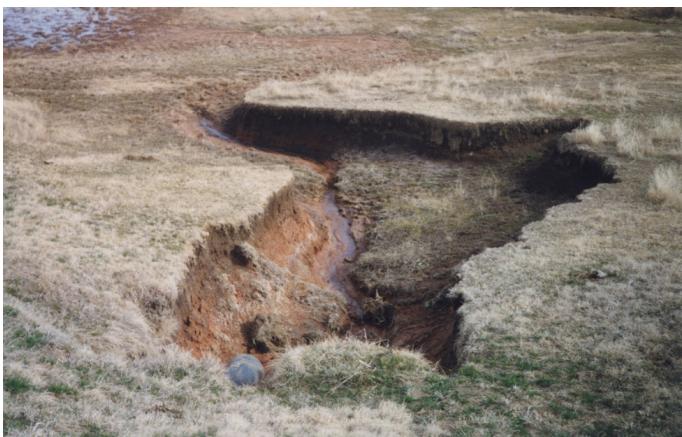
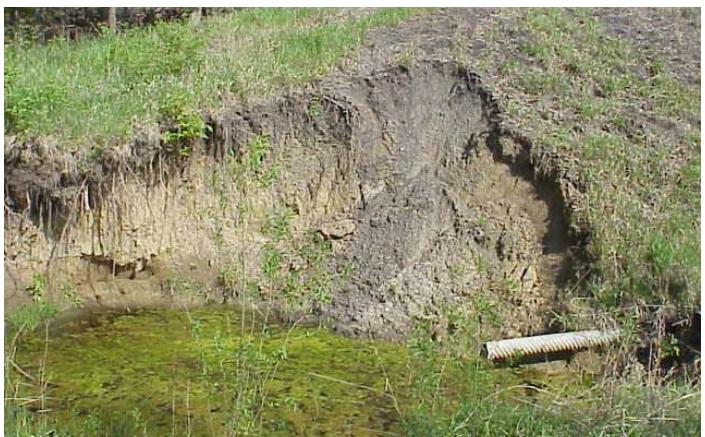
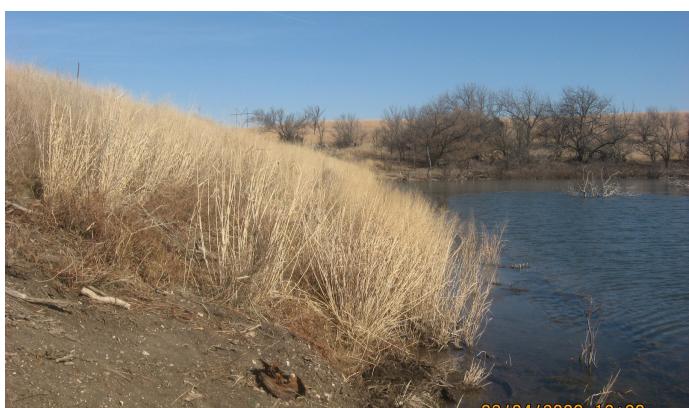
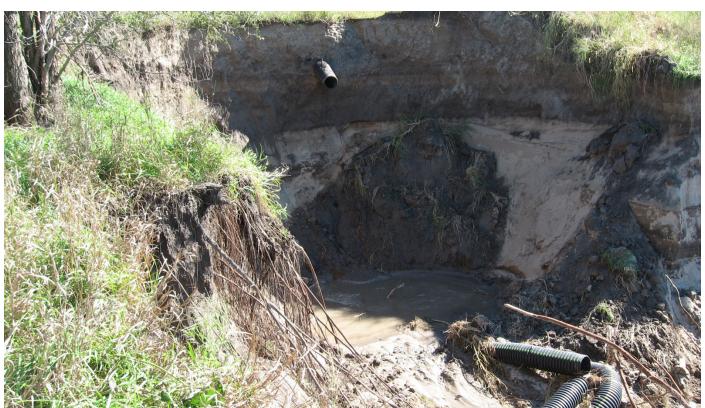
Erosion, which can be internal or external, is the one dam potentiality that must be examined carefully during every inspection before it is too late for corrective actions as seen in these photographs that include Butler County and Marshall County.

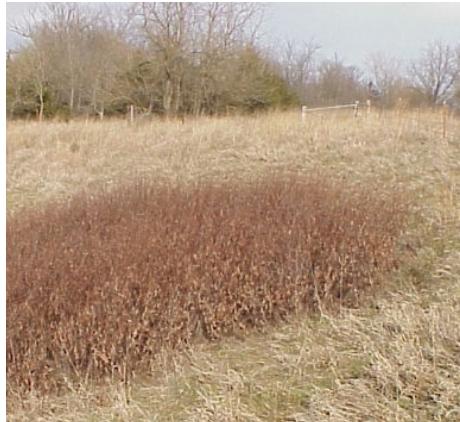
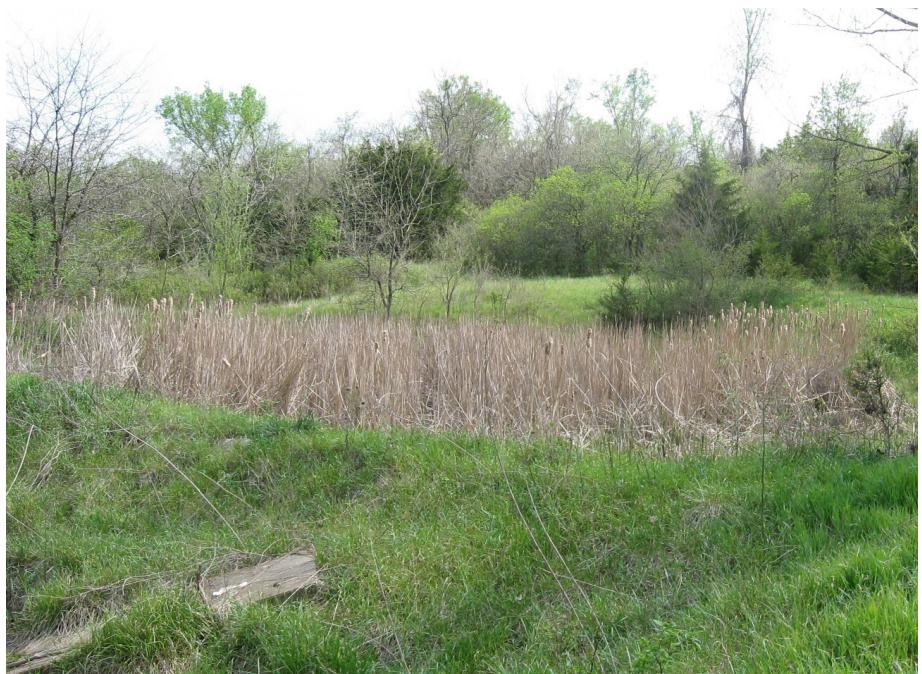
Wetness on a dam, may be evident with springs; water plants such as cattails, or reeds. Watch for increased seepage, especially when reservoirs are at a high level because seepage can lead to embankment erosion. *Left, Douglas County and right, Bourbon County*

Water leaking or passing through or underneath a dam's downstream embankment is seepage. All dams leak; however, the quantity of leakage can be problematic and needs monitoring.

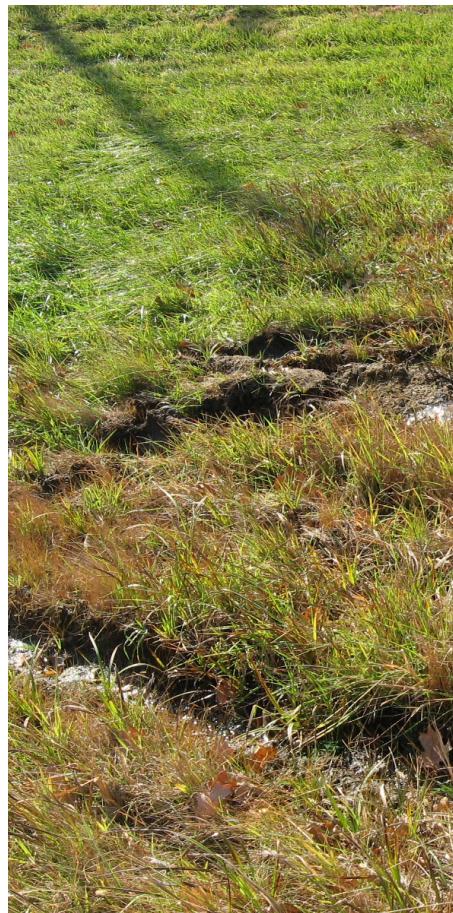
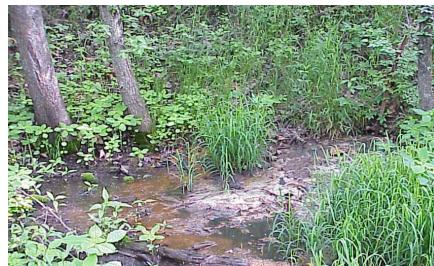
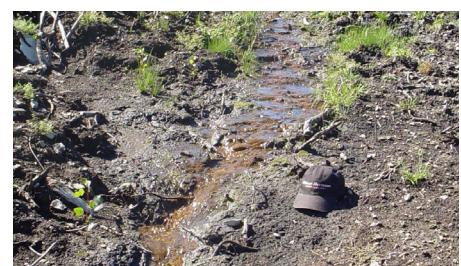
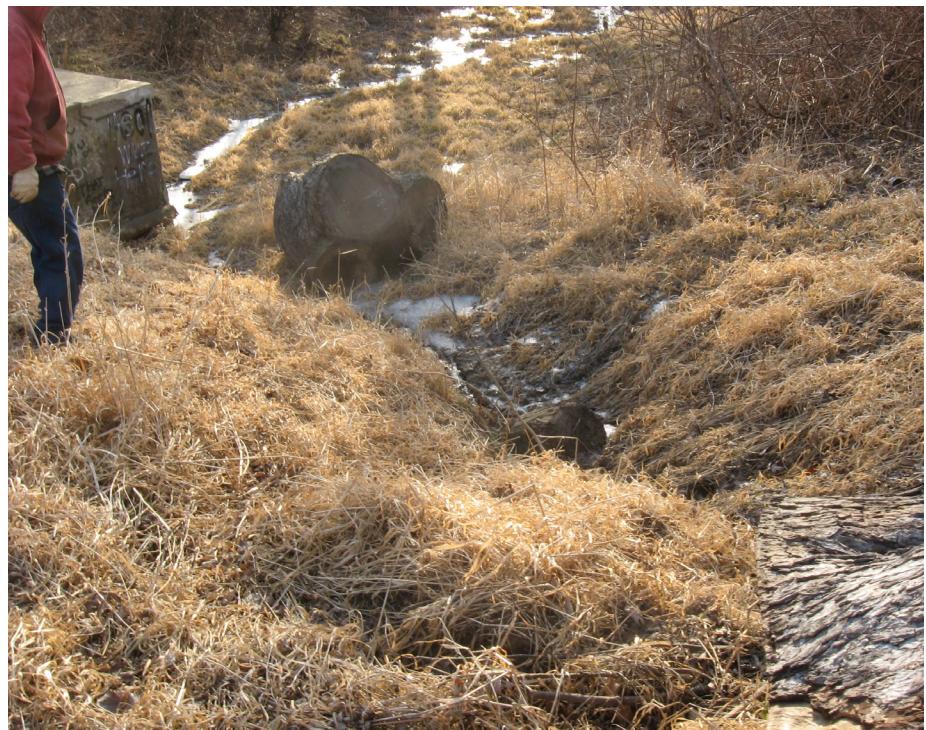
Above and also right, Atchison County seepage evident on left abutment. Above left, Jefferson County seepage.

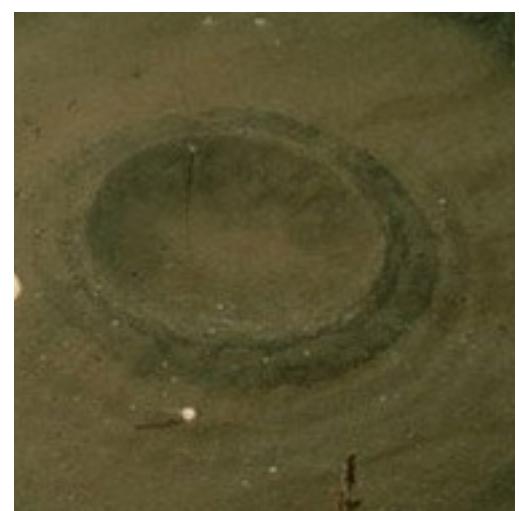
This Doniphan County boil is piping evidence. If a vortex develops, the dam is in danger of immediate failure.

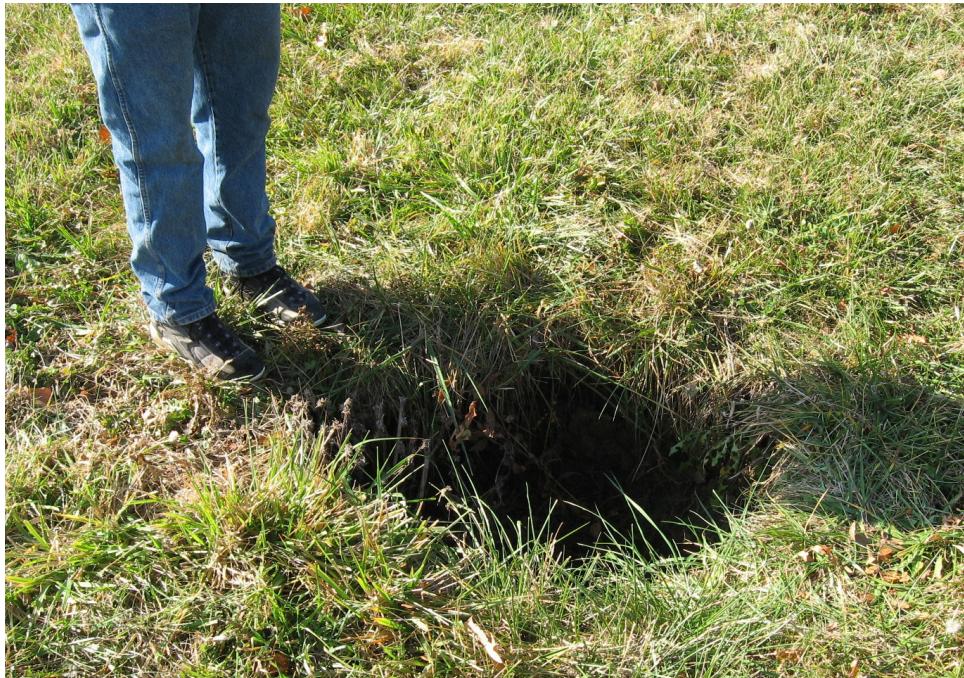
Above, Atchison County

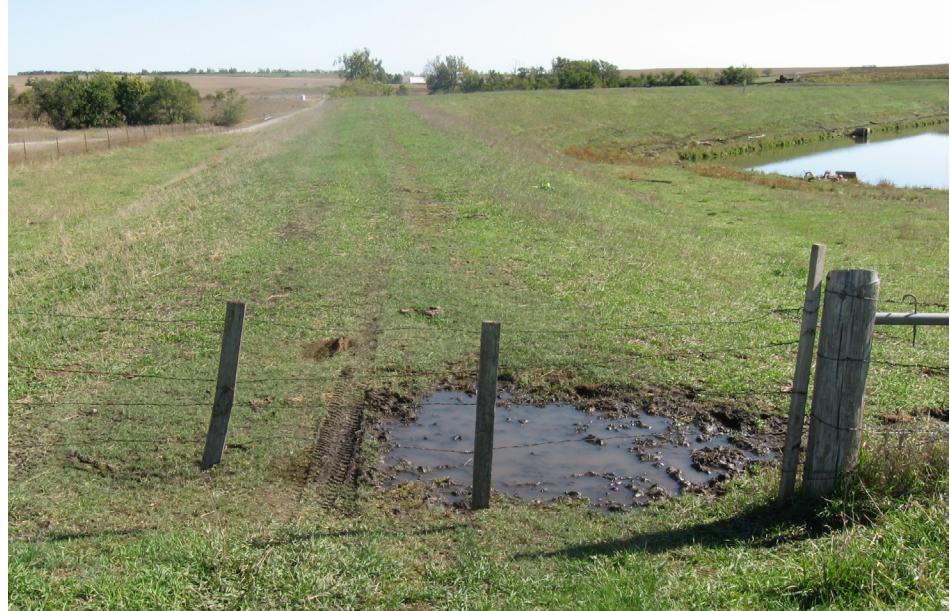
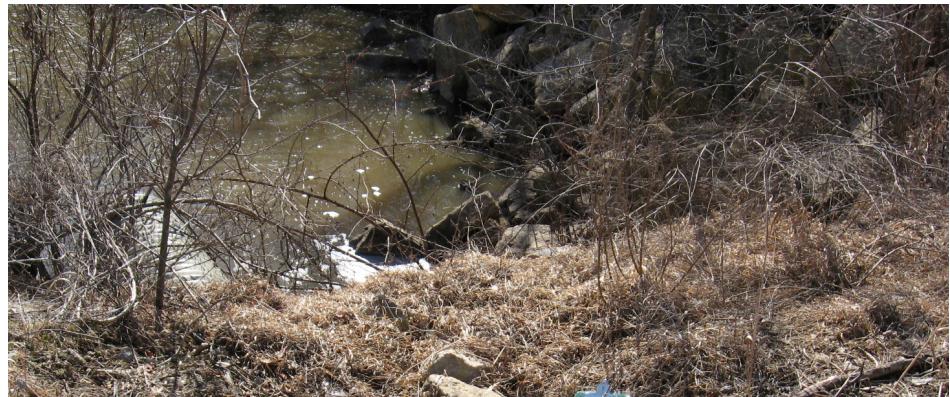
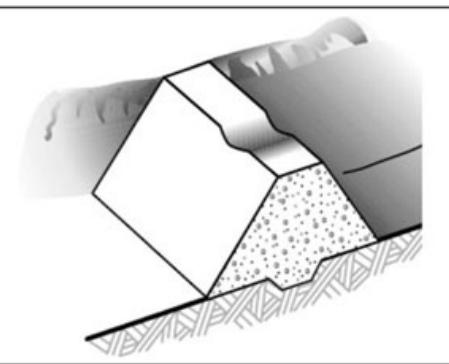
Settlement above in Brown County is not the same as this Jefferson County sinkhole.

An elevation decrease in part of all of a dam indicates a loss of material or inadequate material compression known as settlement. This condition also can result from erosion or inadequate grading and reduces freeboard when at dam top.

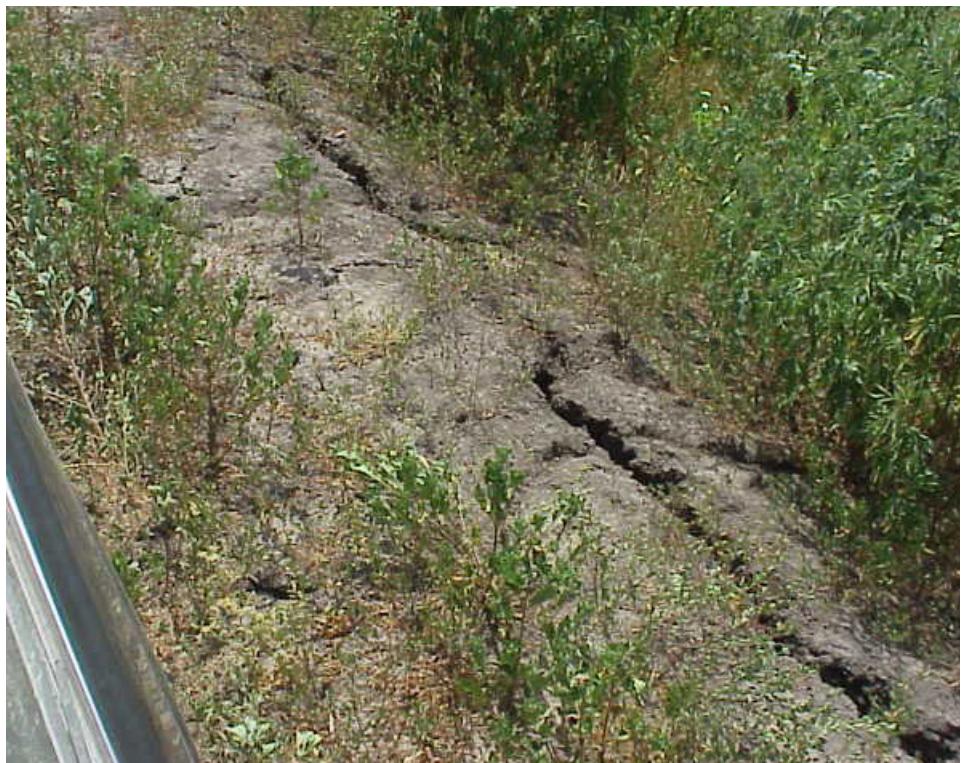
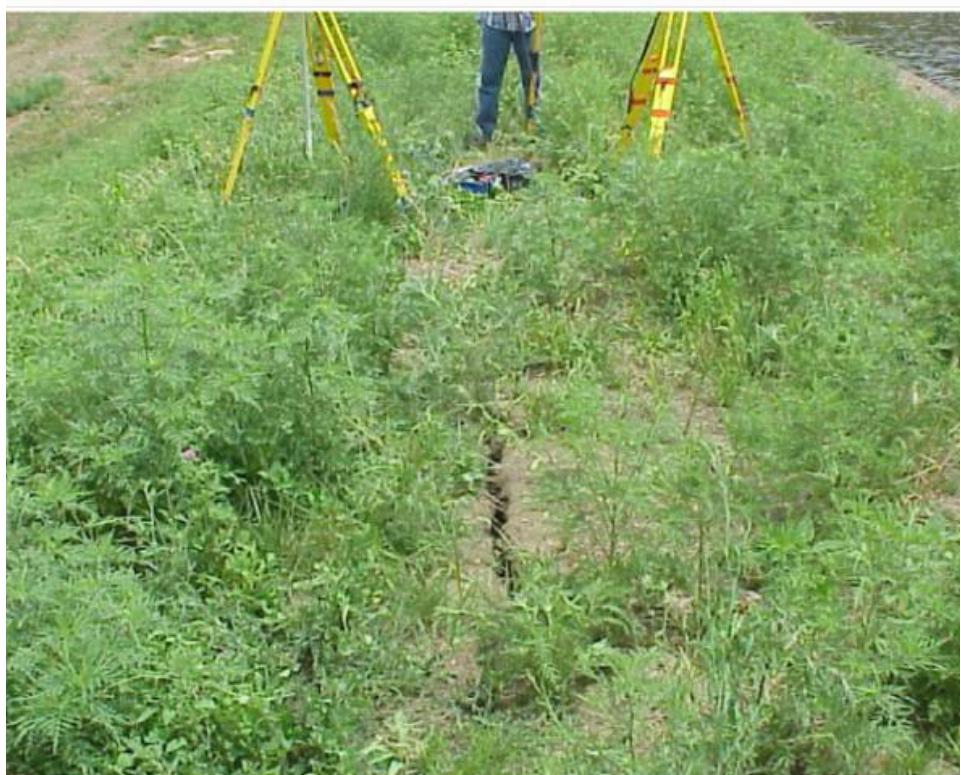
Bourbon County dam

During the building of a dam, longitudinal cracking that runs parallel with the dam length may happen because of insufficient vegetation with roots to hold the soil.

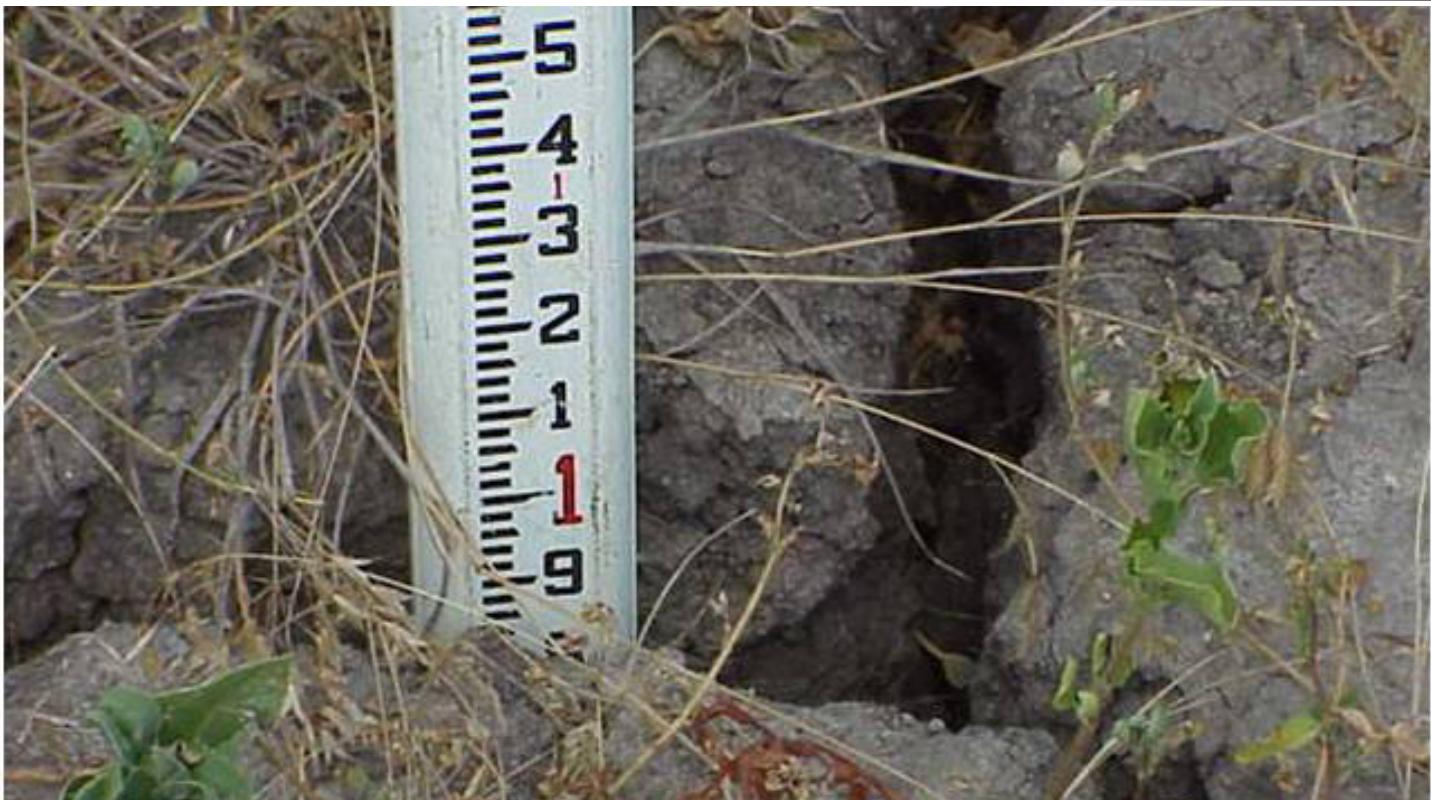
DWR inspectors measured this transverse crack in their inspection report.

Transverse cracking is perpendicular to the centerline of the dam. It can indicate differential settlement within the embankment or foundation. This cracking can result in high seepage rates and piping through a dam, especially if the cracks extend into the dam's core.

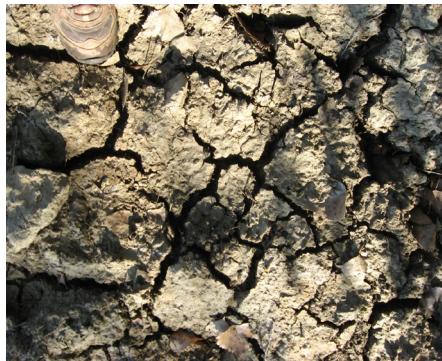
Desiccation cracking will generally be shallow and is caused by drying and wetting of the embankment (especially drying). If this is serious, remove the material and backfill. Most often, a little rain will solve this type of cracking.

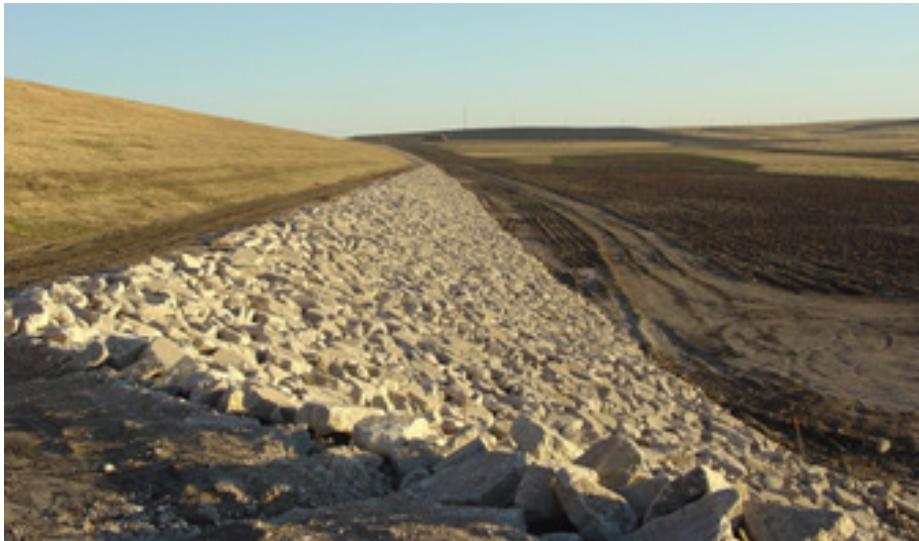
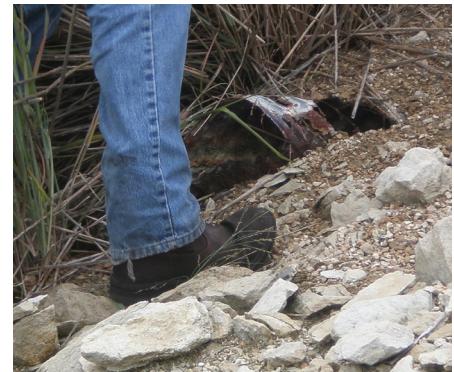
An example of desirable riprap can be seen, left, at this Hodgeman County dam. Below, view eroded riprap needing replacement.

Rock riprap, a common cover material for embankment dams, prevents erosion of dams' upstream faces and may protect during dam overtopping. Consisting of a mix of irregular shaped rocks placed over gravel or geotextile fabric, it absorbs and deflects wave action from the dam. Smaller rocks fill in the spaces between the larger pieces, and a filter prevents soil particles on the embankment surface from washing out between the rock spaces.

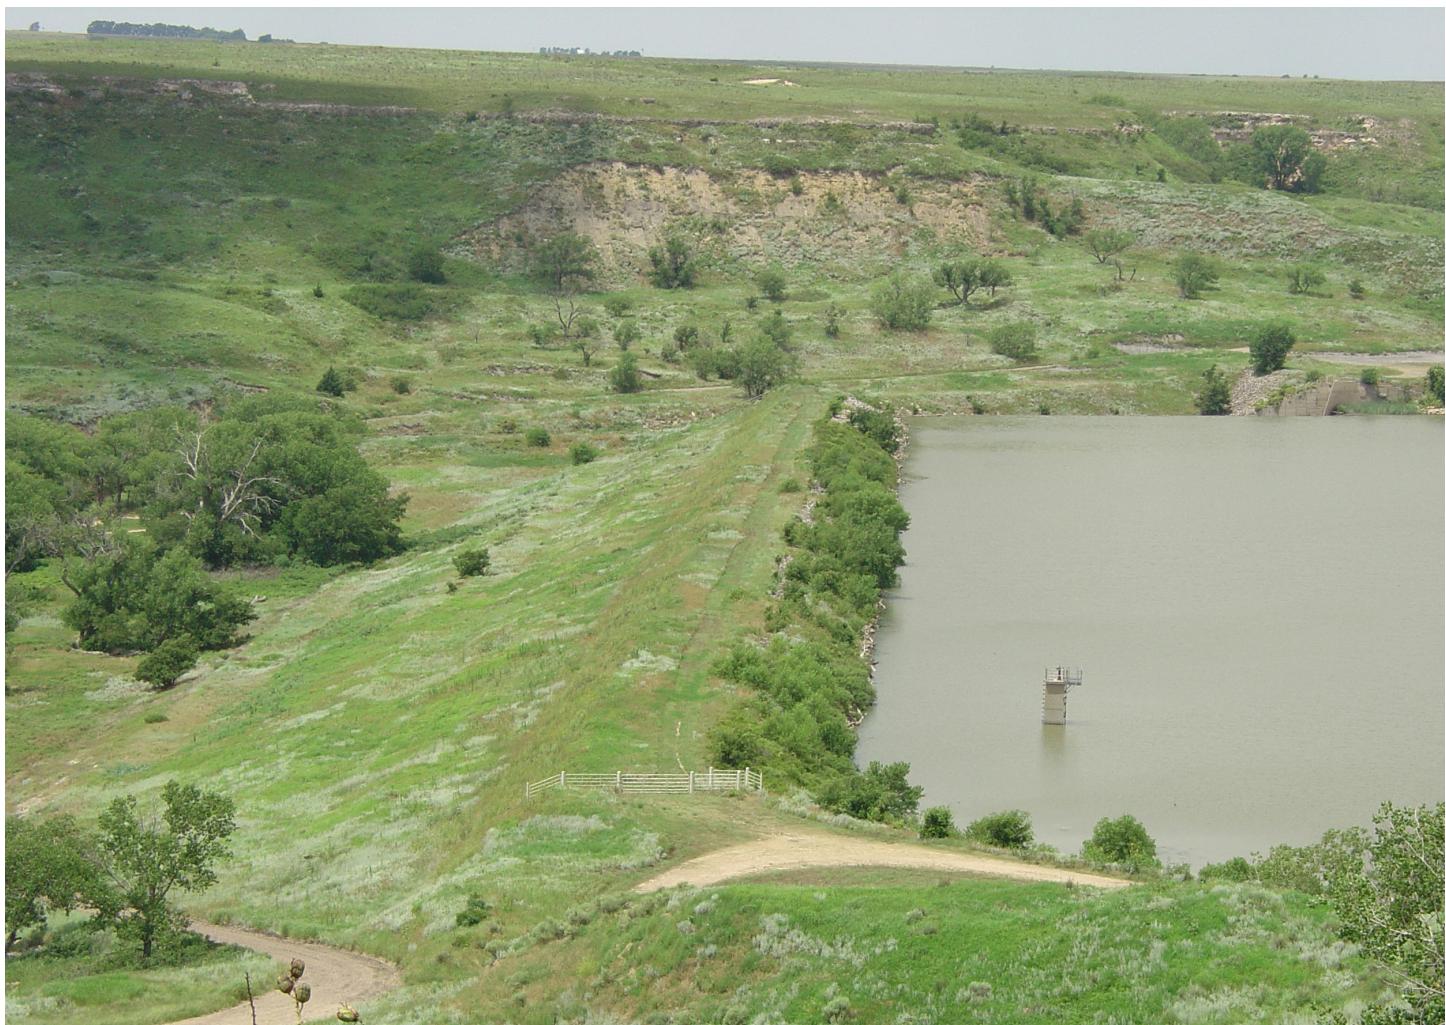
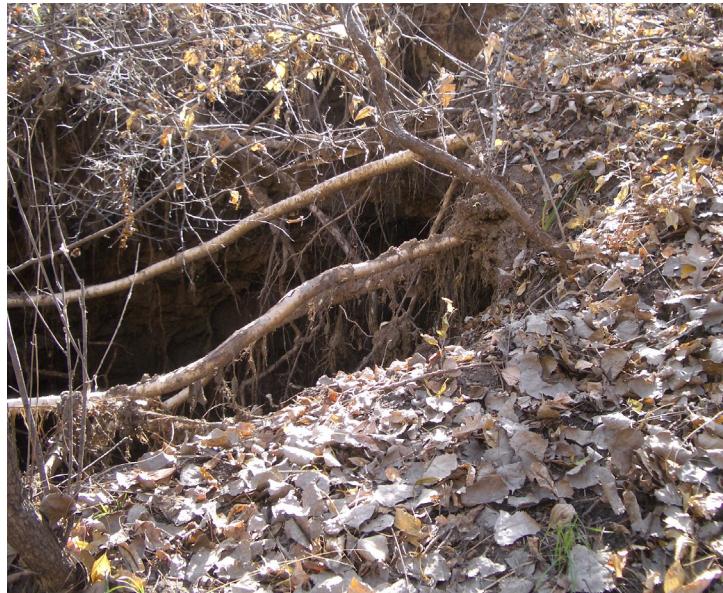
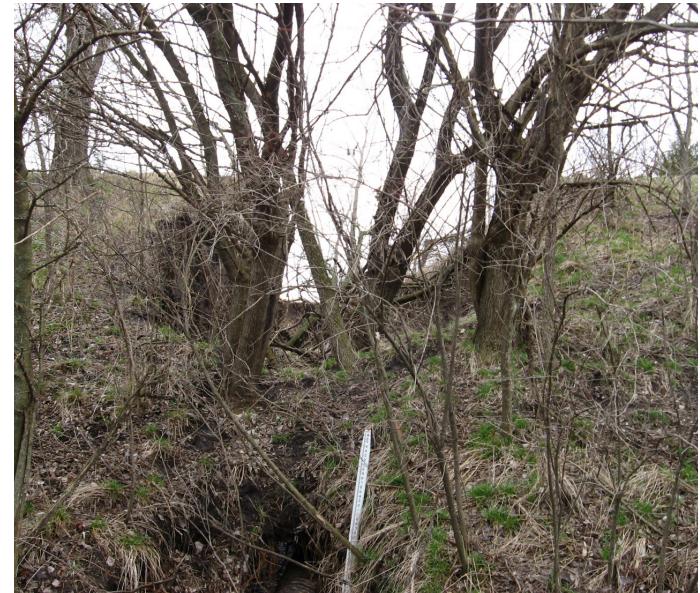
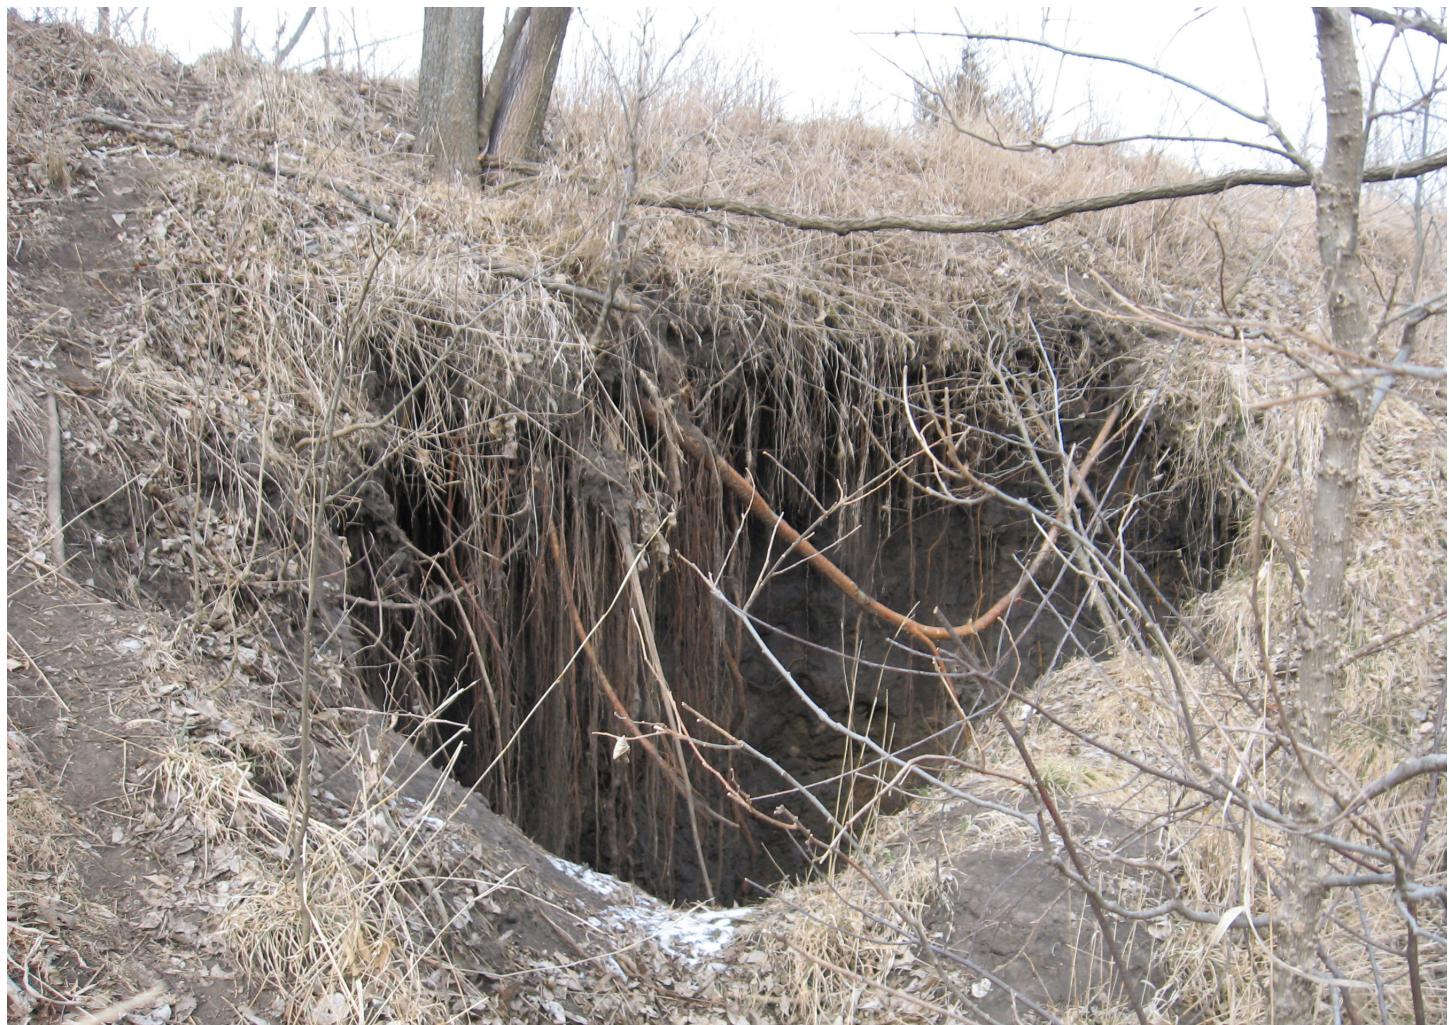
Photographs on this page show voids made in Kansas dams as a result of tree root damage. While roots may increase soil shear and tensile strength, which increases resistance to mass failure on unstable dam slope embankments, the impact is minimal. Because of their safety magnitude, trees of substantial size should be removed under the direction of a qualified professional engineer. Any questions regarding tree removal may be directed toward DWR because a permit may be required.

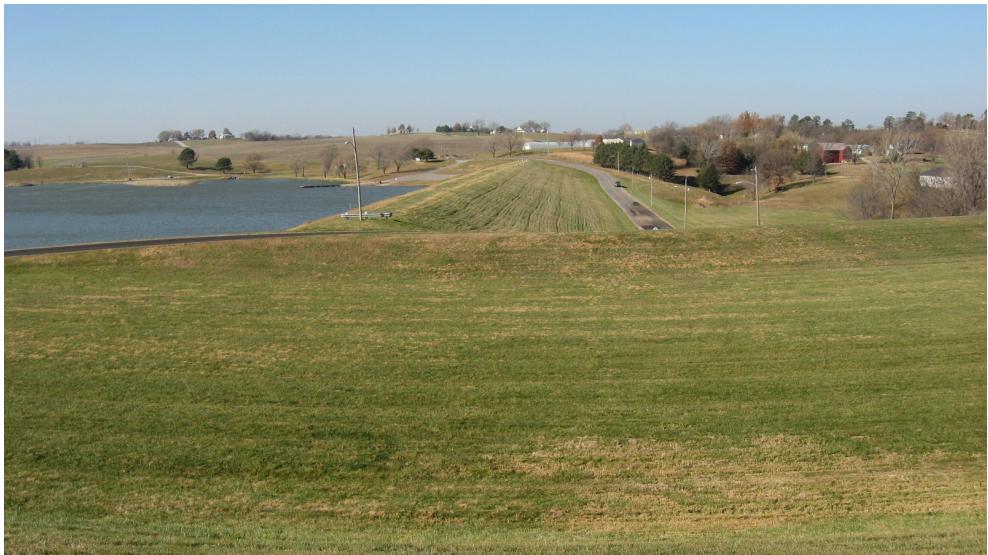
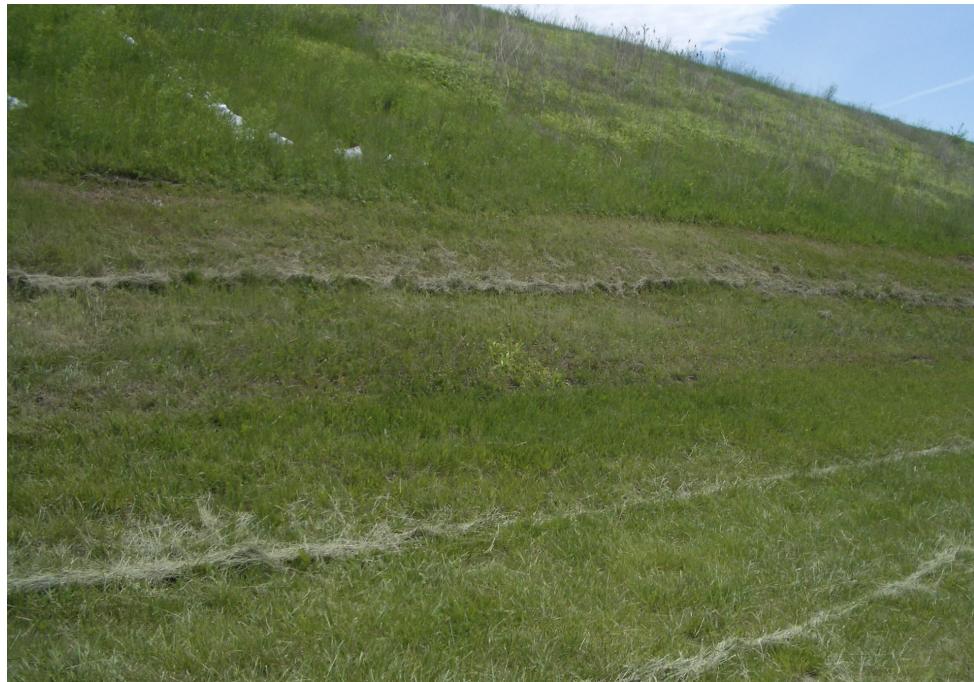
Mowing before inspection, as seen above on Mission Lake in Brown County, makes potential dam safety problems easier to spot. Right, conduits and spillway need to be free of vegetation to properly function.

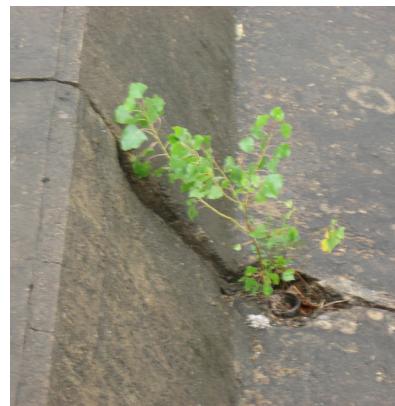
Fill joints and cracks with appropriate filler.

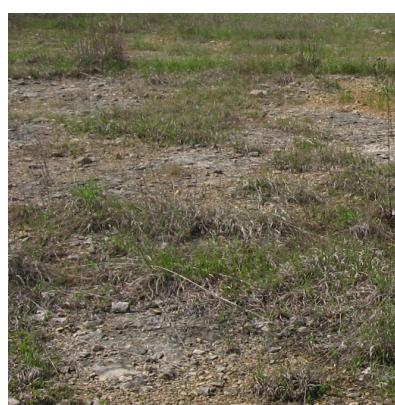
Reseeding helps establish a desirable surface that prevents erosion.

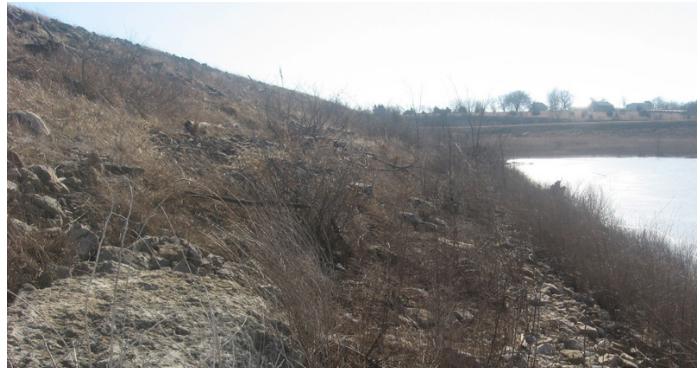
Unprotected embankment subject to wave action can erode into vertical face to form into a benching condition, which diminishes a dam's maximum storage.

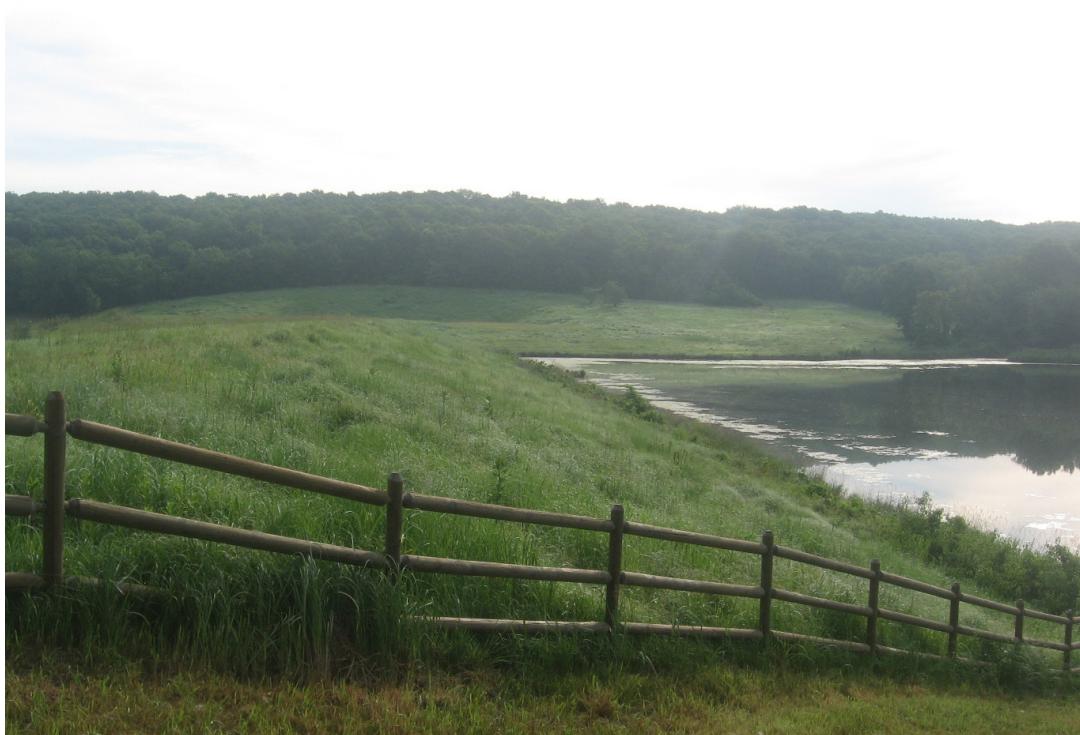
DWR inspectors have found most fences on Kansas dams are made of barbwire and usually are on the front slope to keep livestock off the dam. Check posts to see whether loose, bent, or broken and also wire tension and condition.

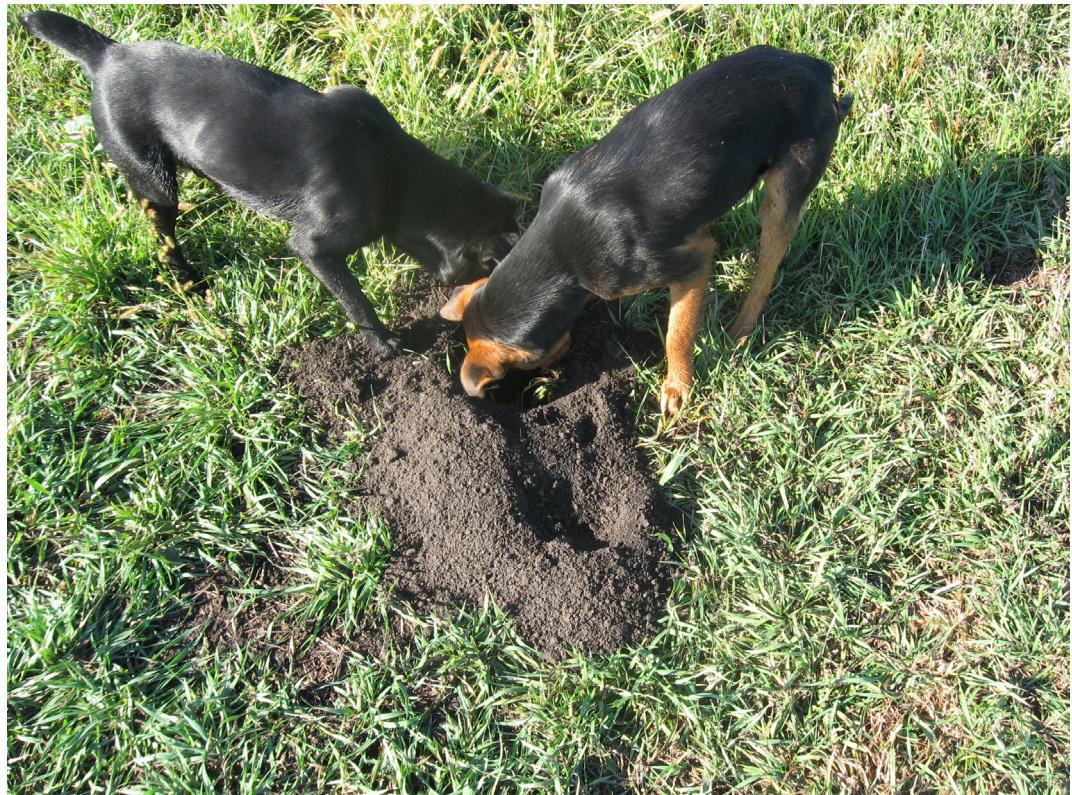
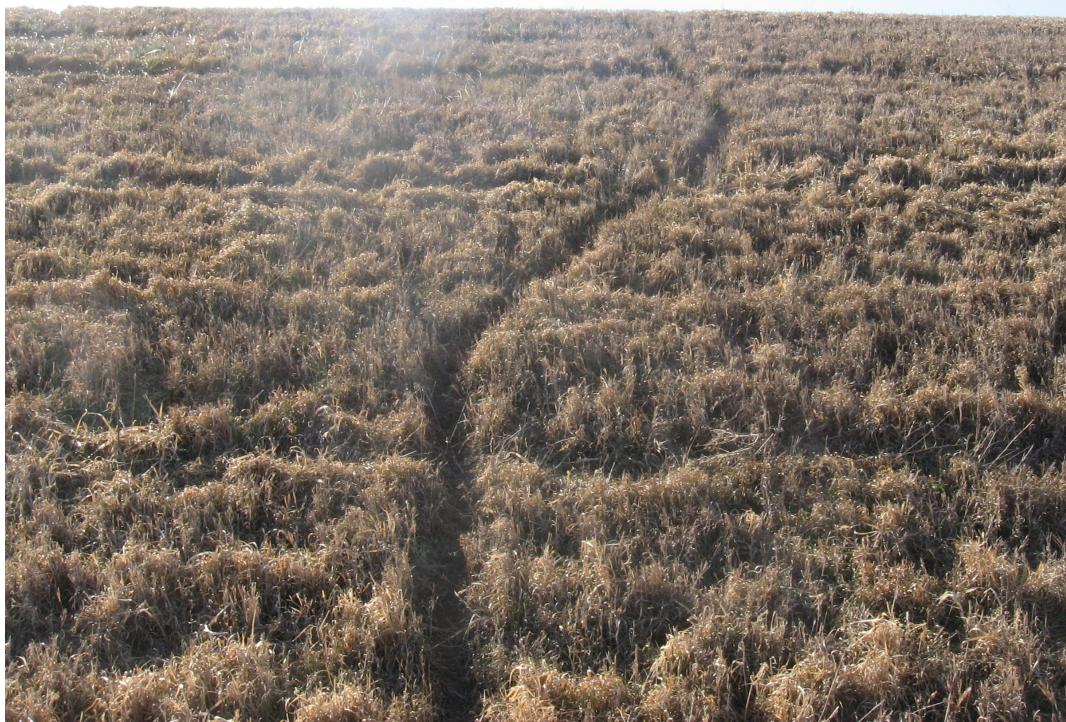
This path on an Atchison County dam indicates the presence of burrowing animals.

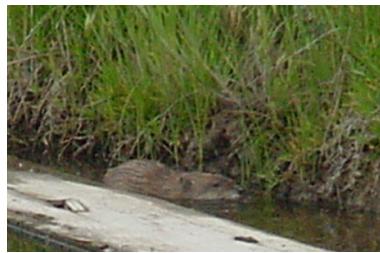
Beaver burrows often run deep below the dam surface causing hydraulic alteration and structural integrity loss. Beavers can lock a dam's spillway and intake structure with building materials, which raises the reservoir water level in a reservoir and impairs spillway integrity. Besides trapping, devices such as The Clemson University Beaver Pond Leveler, seen below, can retain beaver building benefits and maintain a dam's structure.

Elbow and stand pipe are optional.  
Needed only to manage water level  
if maintaining pond is an objective

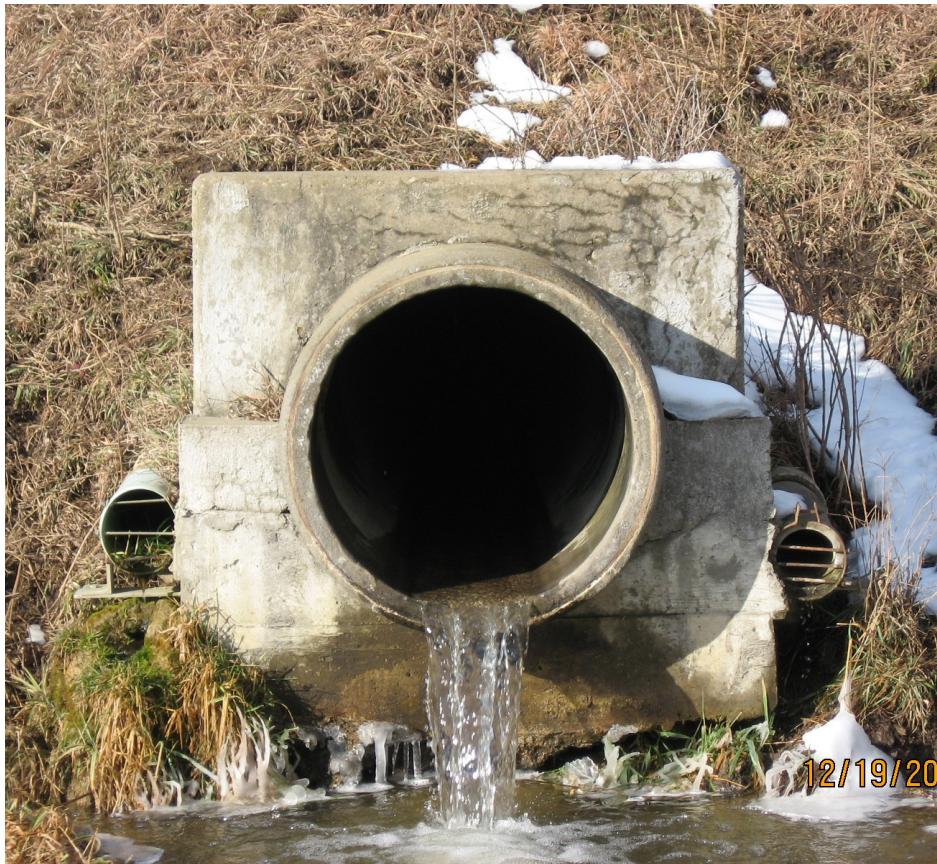
The above photograph shows evidence of erosion by the pipe that needs to be corrected. Below, corrugated metal pipe in Pottawatomie County has outlived its lifespan and needs replacement.

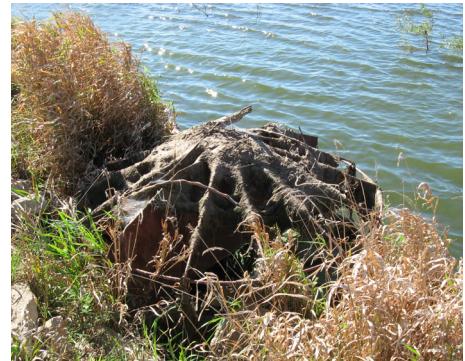
Check for damage, obstruction, or corrosion of trash rack.

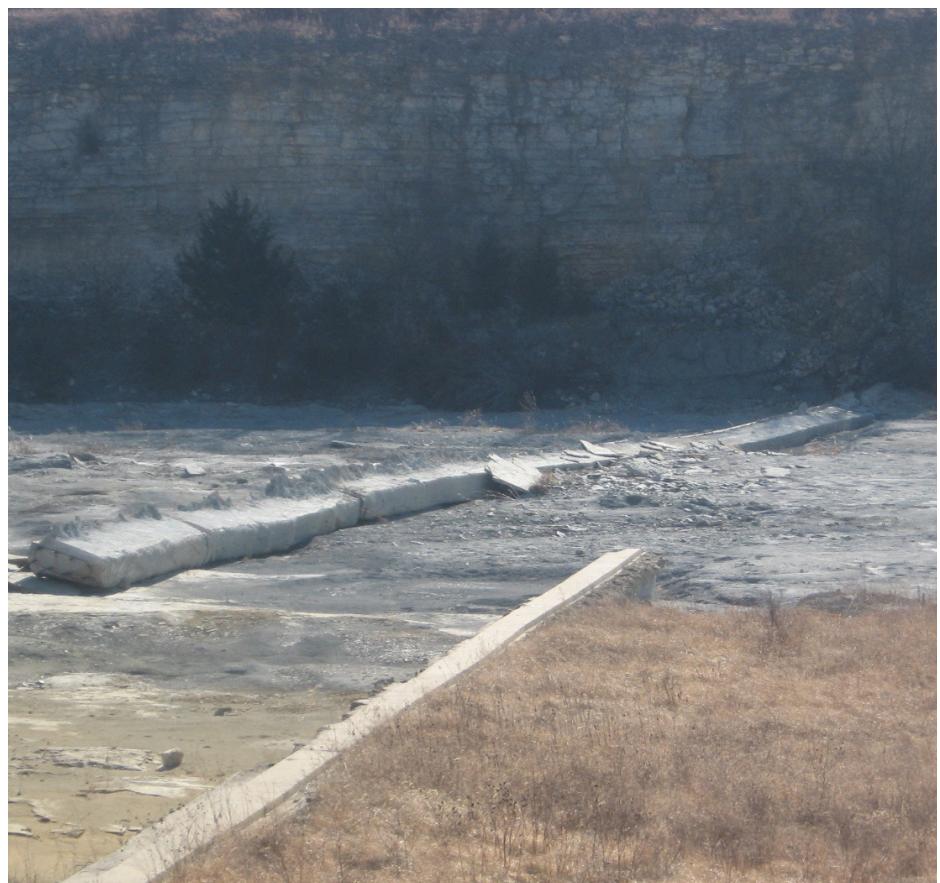
Damaged control section in auxilliary spillway at Cedar Lake by Garnett

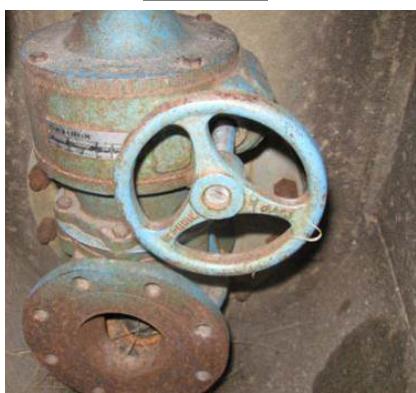
**VALVES**

Valve should be operated annually to ensure functionality. Cleans dirt and debris within valve.
