Project: Long-Scott Creeks Watershed District No. 93
Site 6-9 Dam Rehabilitation

Location: SE 1/4 Sec 9, T-20S; R-16E
Coffey County, Kansas

Index to Drawings

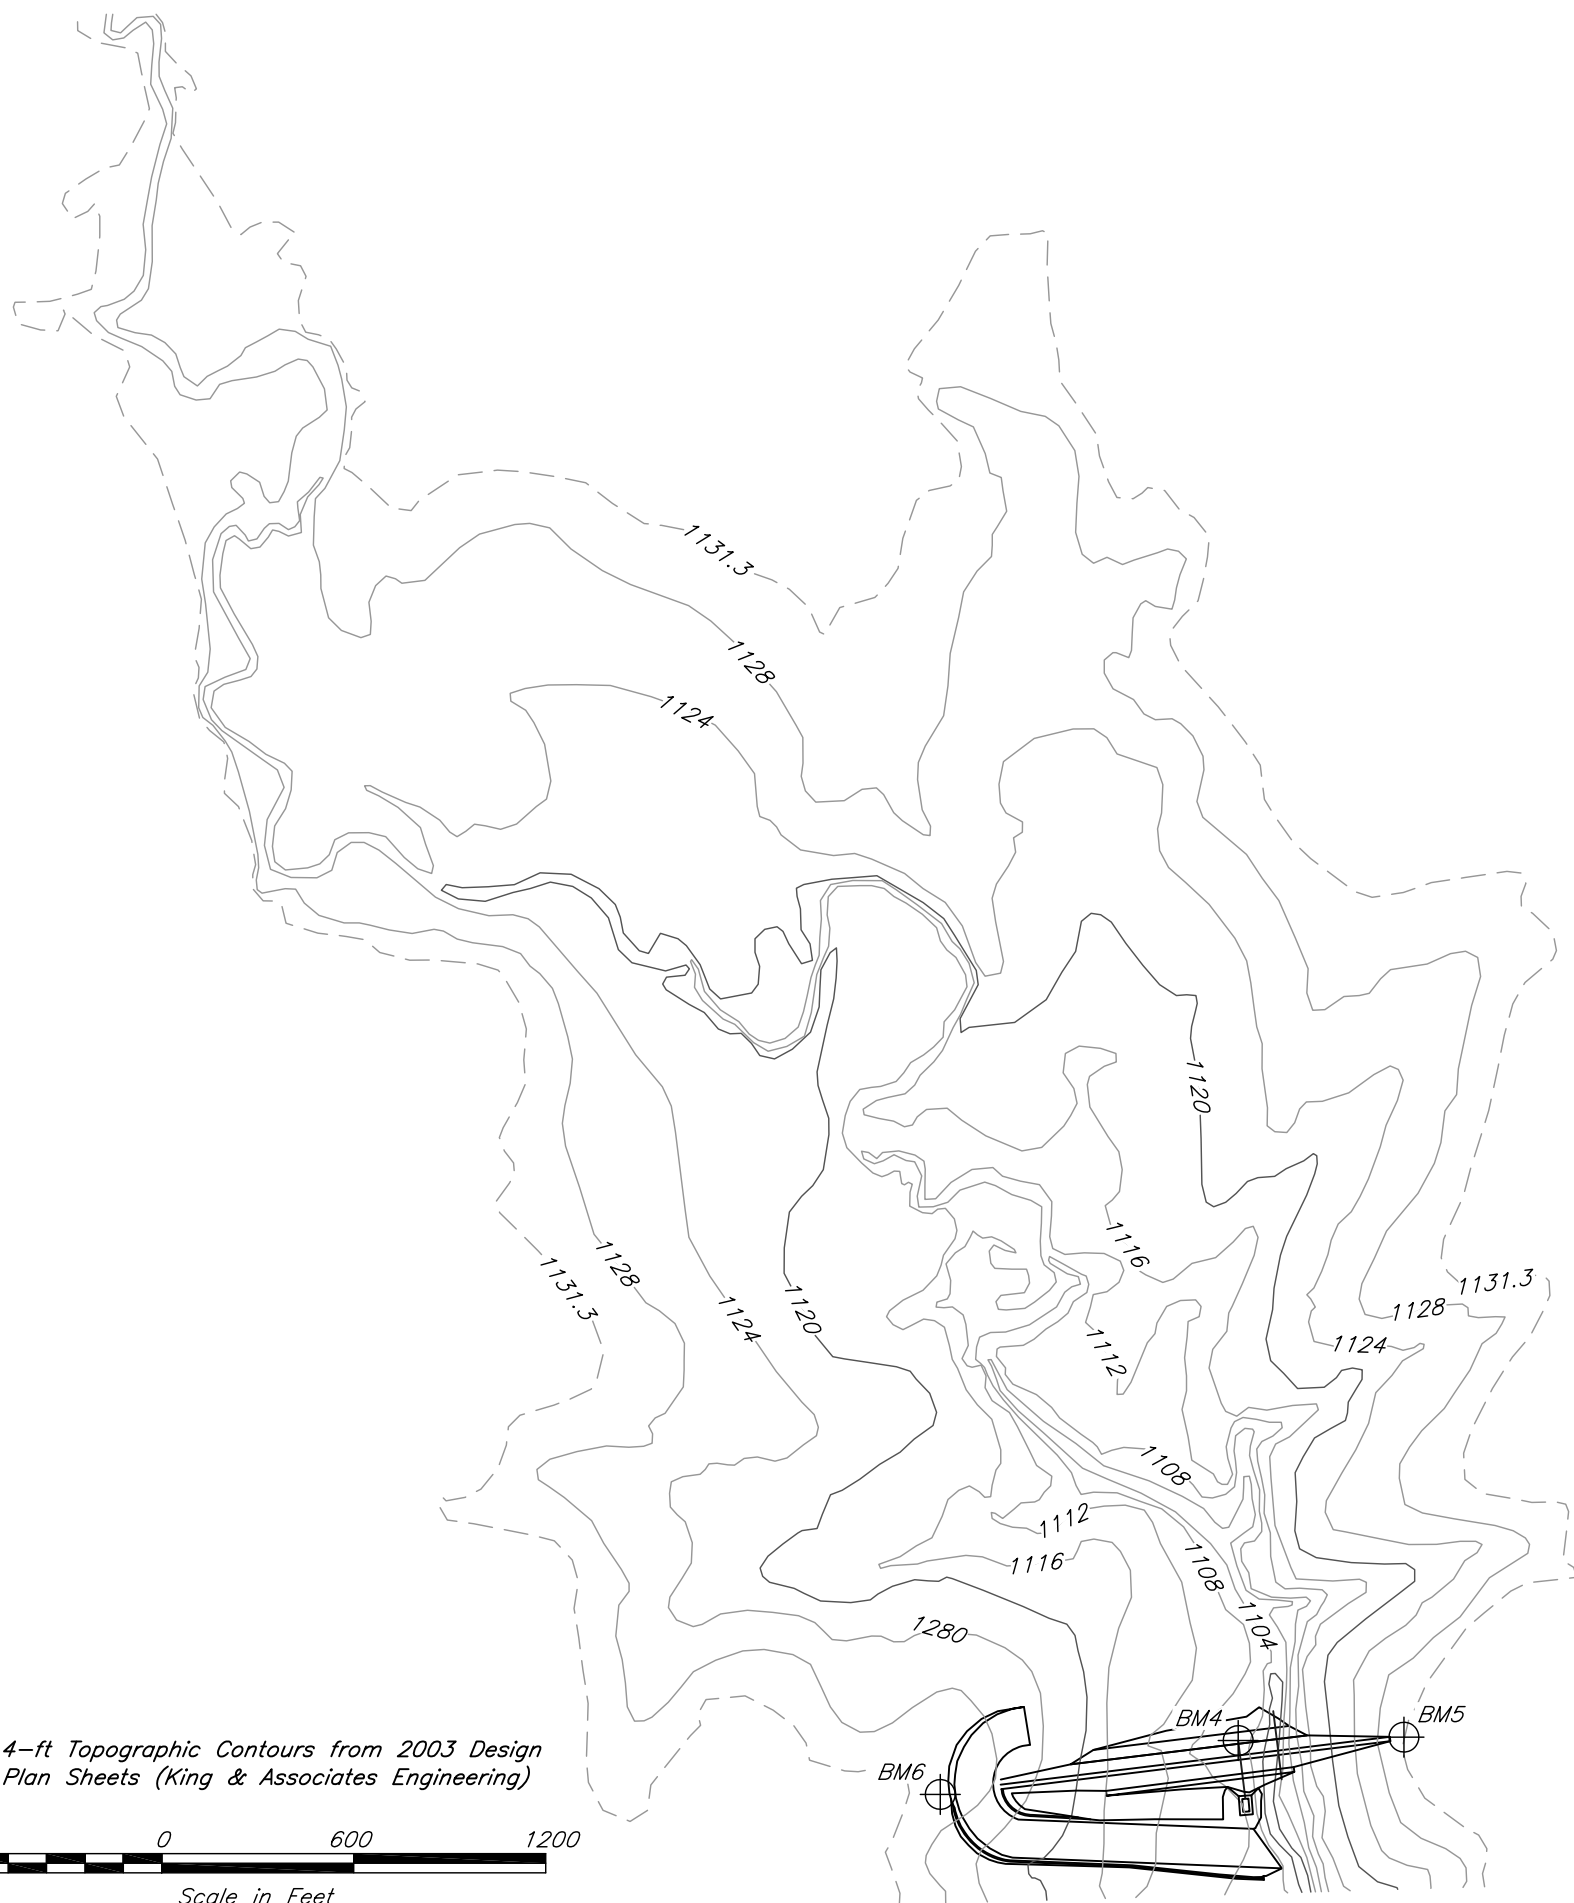
Topographic Plan Map and Site Information

Storage Table			
Elevation (ft)	Area (ac)	Volume (ac-ft)	Total Volume (ac-ft)
1096	0	0	0
1100	0.20	0.40	0.40
1104	0.62	1.64	2.04
1108	3.72	8.68	10.7
1112	17.9	43.2	53.9
1116	36.8	109	163
PS 1118	57.2	94.0	257
1120	77.5	135	392
1124	136	427	819
ASW 1125.5	163	224	1043
1128	208	464	1507
TOD 1131.3	267	784	2290

Benchmark Table				
Benchmark	Northing	Easting	Survey Elevation	Description
BM4	1926547.27	2132332.17	1118.00	Crest of inlet riser
BM5	1926552.68	2132852.00	1132.95	Top of rebar on dam centerline, Sta 10+85
BM6	1926373.91	2131403.33	1130.29	Top of rebar on dam centerline, Sta 25+45

Site 6-9 Information
 NID ID: KS09292
 DWR WSN: DCF-0098
 DWR Class Size: 4
 Hazard Classification: Significant

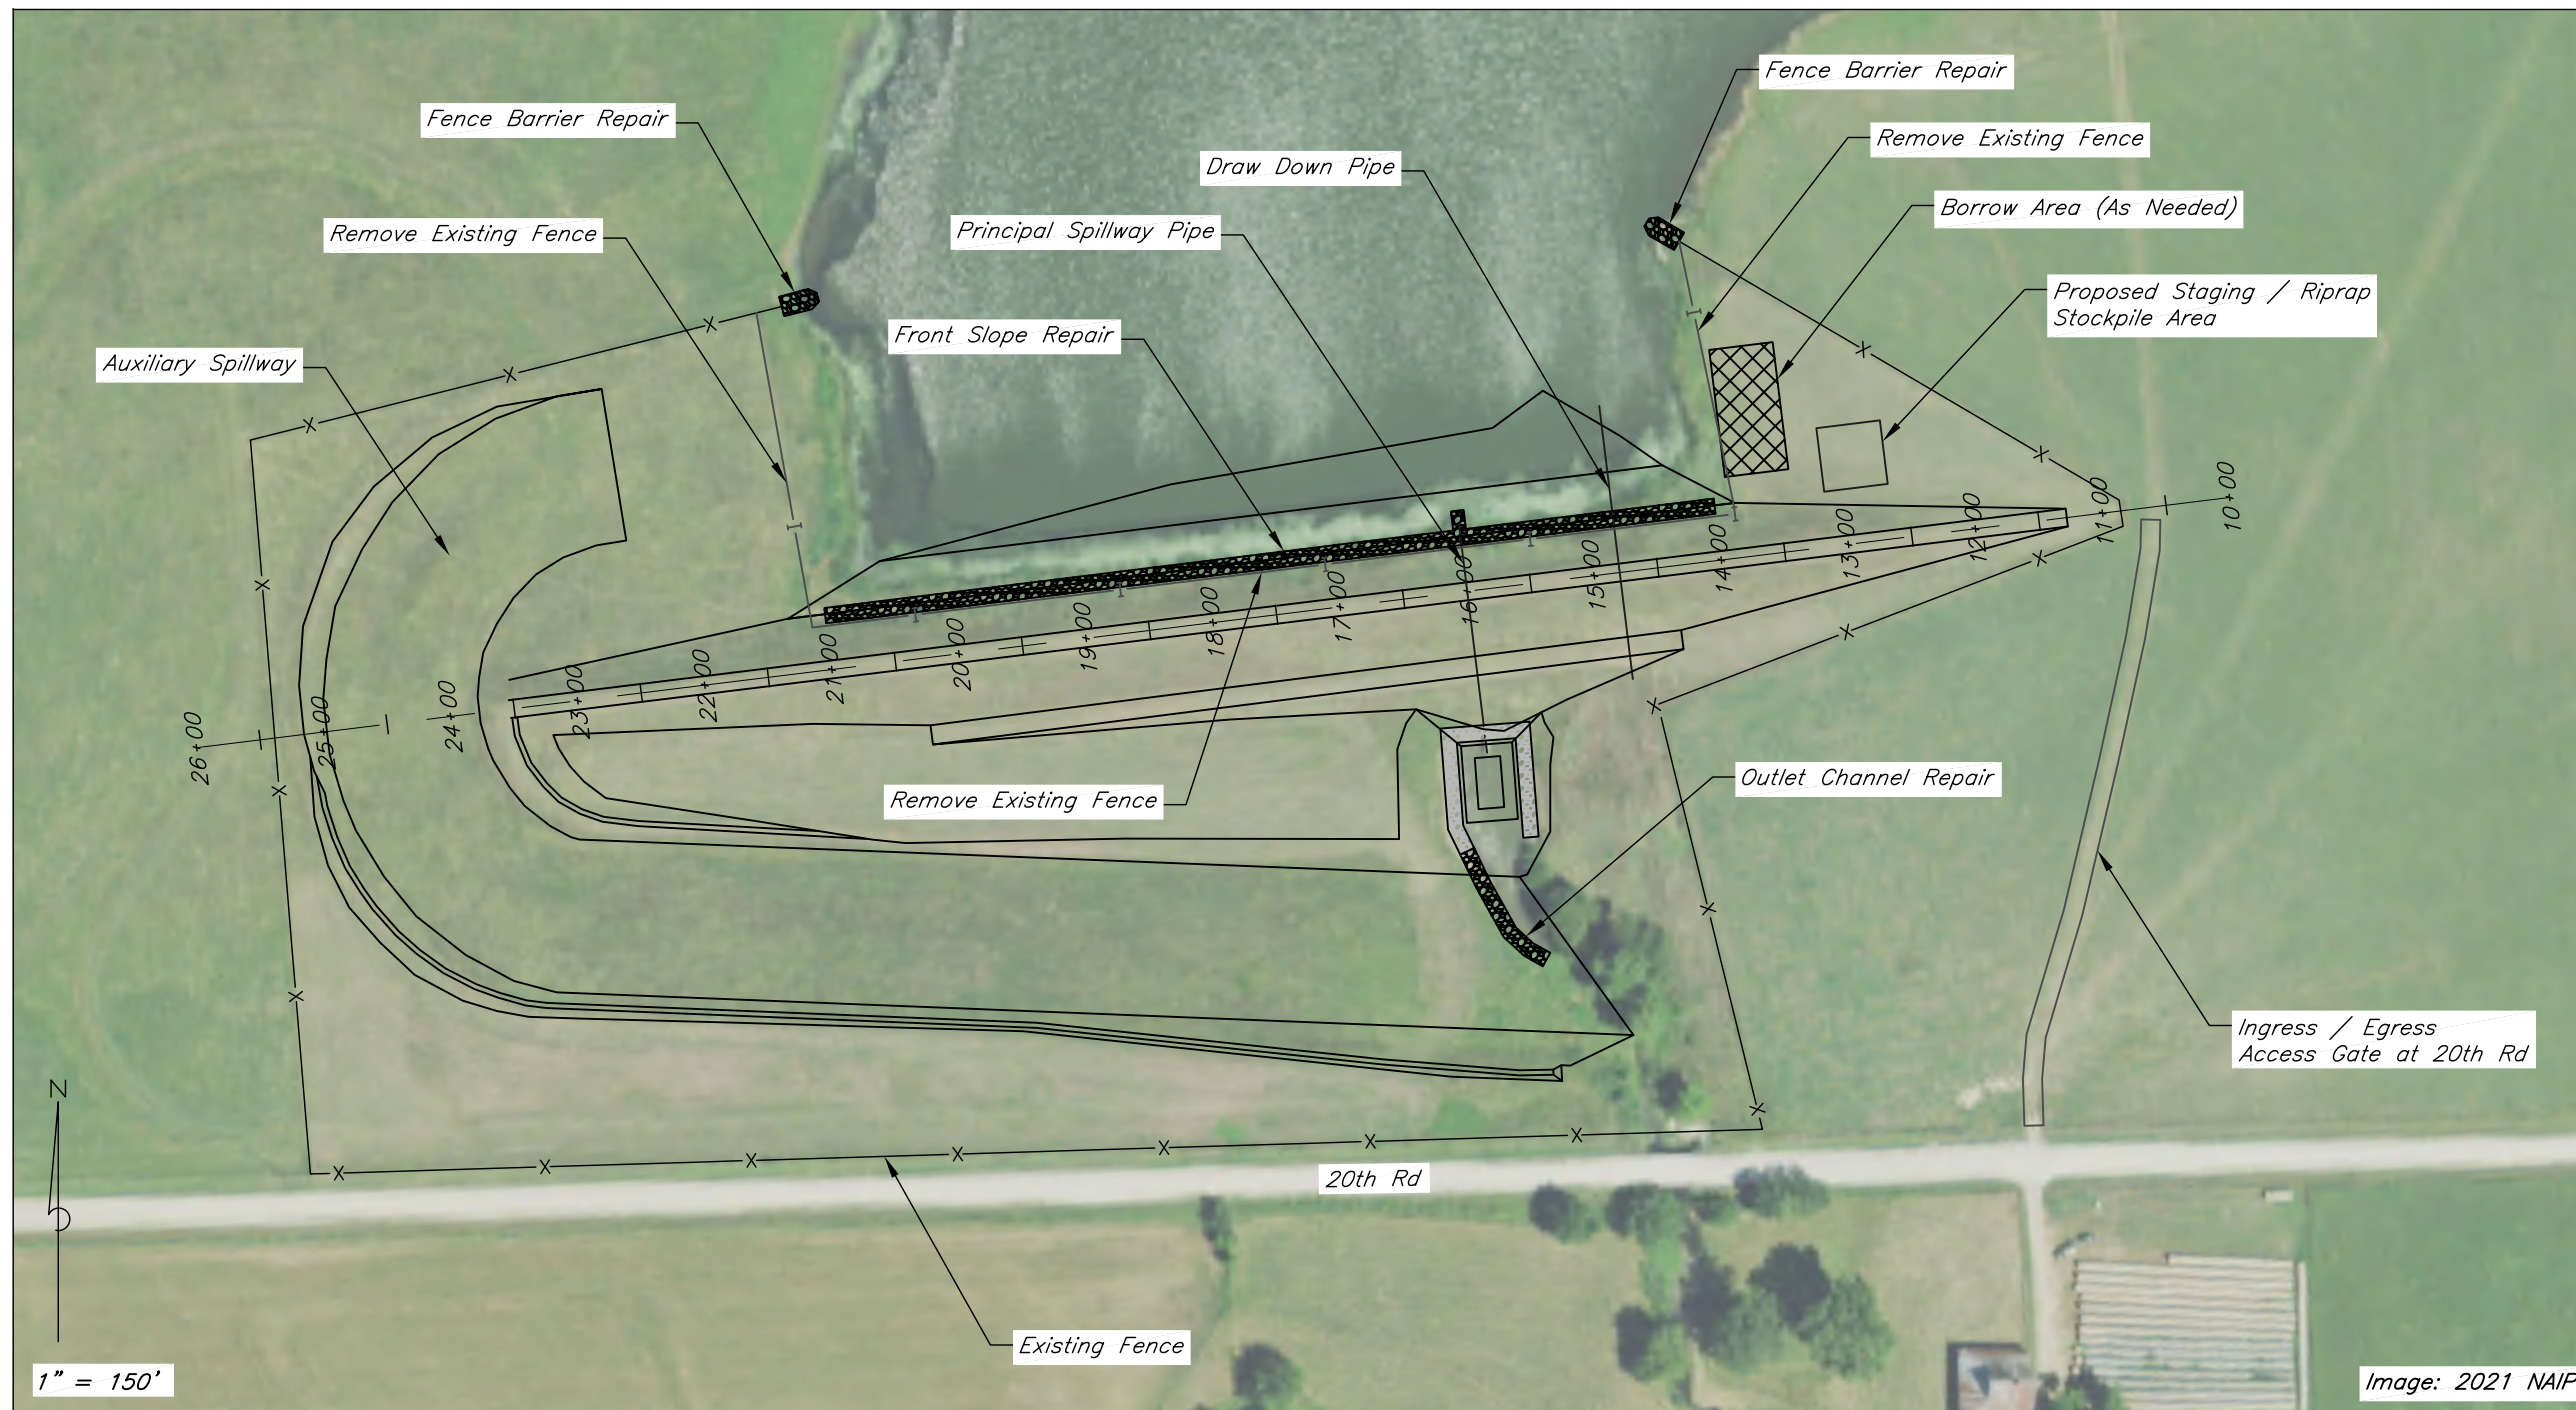
Orthographic Plan Map

Repair Descriptions

Front Slope Repair (see detail on sheet 5 of 8):

- Front toe excavation
- Rock riprap placement

Outlet Channel Repair (see detail on sheet 6 of 8):

- Bank excavation
- Rock riprap placement

Fence Removal and Barrier Repair (see detail on sheet 7 of 8):

- Remove and dispose of existing fence
- Fence barrier installation (rock riprap)

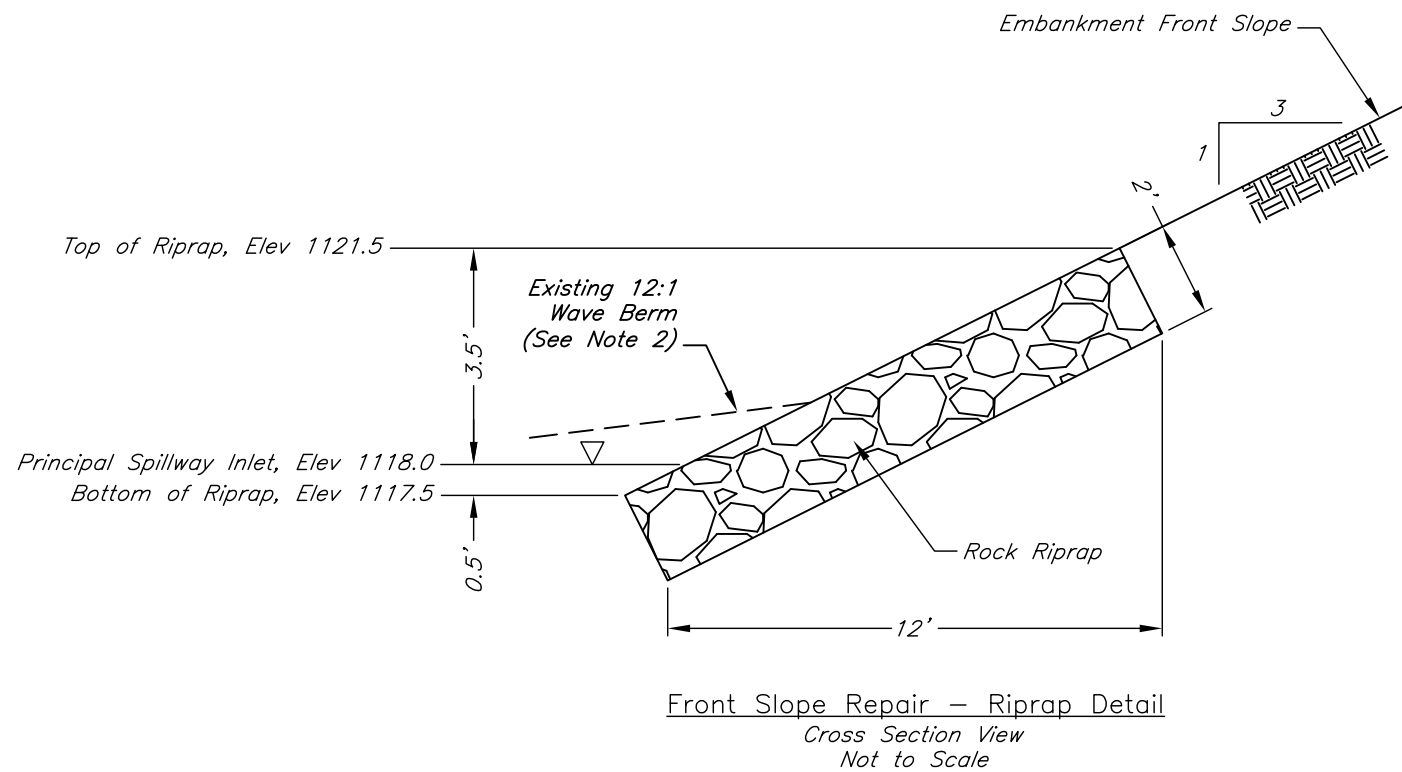
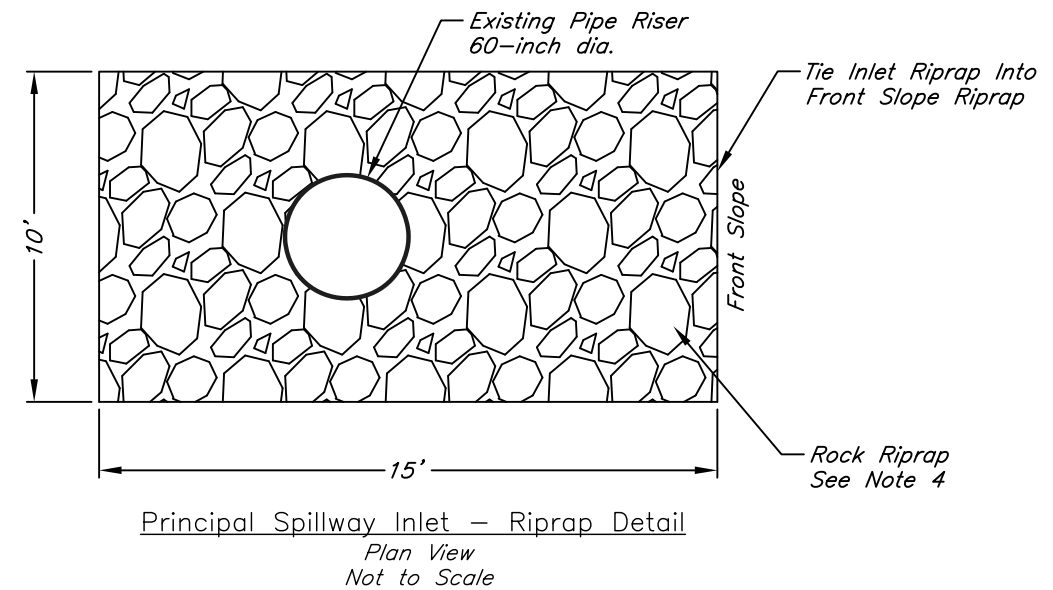
Front Slope Repair Detail

- 1) Rock riprap shall be placed along the embankment front slope from Sta 14+00 – Sta 21+00
- 2) The existing 12:1 wave berm is eroded. As-built, the wave berm started at Elev 1119.0. The wave berm will not be reconstructed to match as-built elevation and dimension. The excavation shall extend into the wave berm as needed to meet the front slope repair detail dimensions and elevations.

- 3) The existing front slope shall be excavated to the dimension and elevation shown in the detail. Excavated material shall be blended into the embankment slope or scattered throughout the riprap after placement is complete.

- 4) The principal spillway inlet riprap shall be 2 feet thick.
- 5) The construction staging area for equipment and rock stockpile shall be mutually determined by the Contractor and Project Engineer.

- 6) Rock riprap gradation shall meet KDOT Stone for Riprap Class – Light Series, Light 24' or Light 18"
- 7) Riprap quality shall meet KDOT Stone for Riprap – soundness and wear requirements.

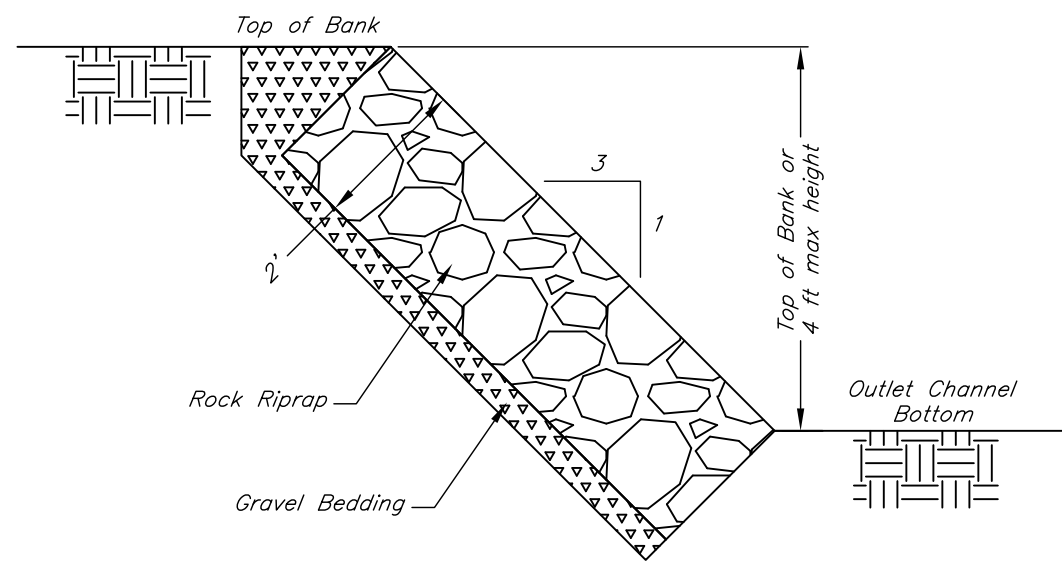
Outlet Channel Repair Detail

Outlet Channel Bank Repair Detail

- Stilling Basin Bank Repair Notes:*
- 1) Repair location starts at the downstream end of the existing stilling basin riprap. Repair extends approximately 125 feet along outlet channel bank.
 - 2) Reshape the existing outlet channel bank to create a 3H:1V finished slope.
 - 3) Remove gravel deposition in the stilling basin and line the reshaped slope to create a base for the larger riprap material.
 - 4) Place rock riprap along the reshaped bank slope to the dimensions shown in the drawing detail.
 - 5) Rock will extend into the outlet channel. The toe of the riprap shall be below the existing channel elevation.
 - 6) Earthen excavation shall be placed along the top edge of the rock slope. The finished surface shall be smoothed to allow for grass seeding.

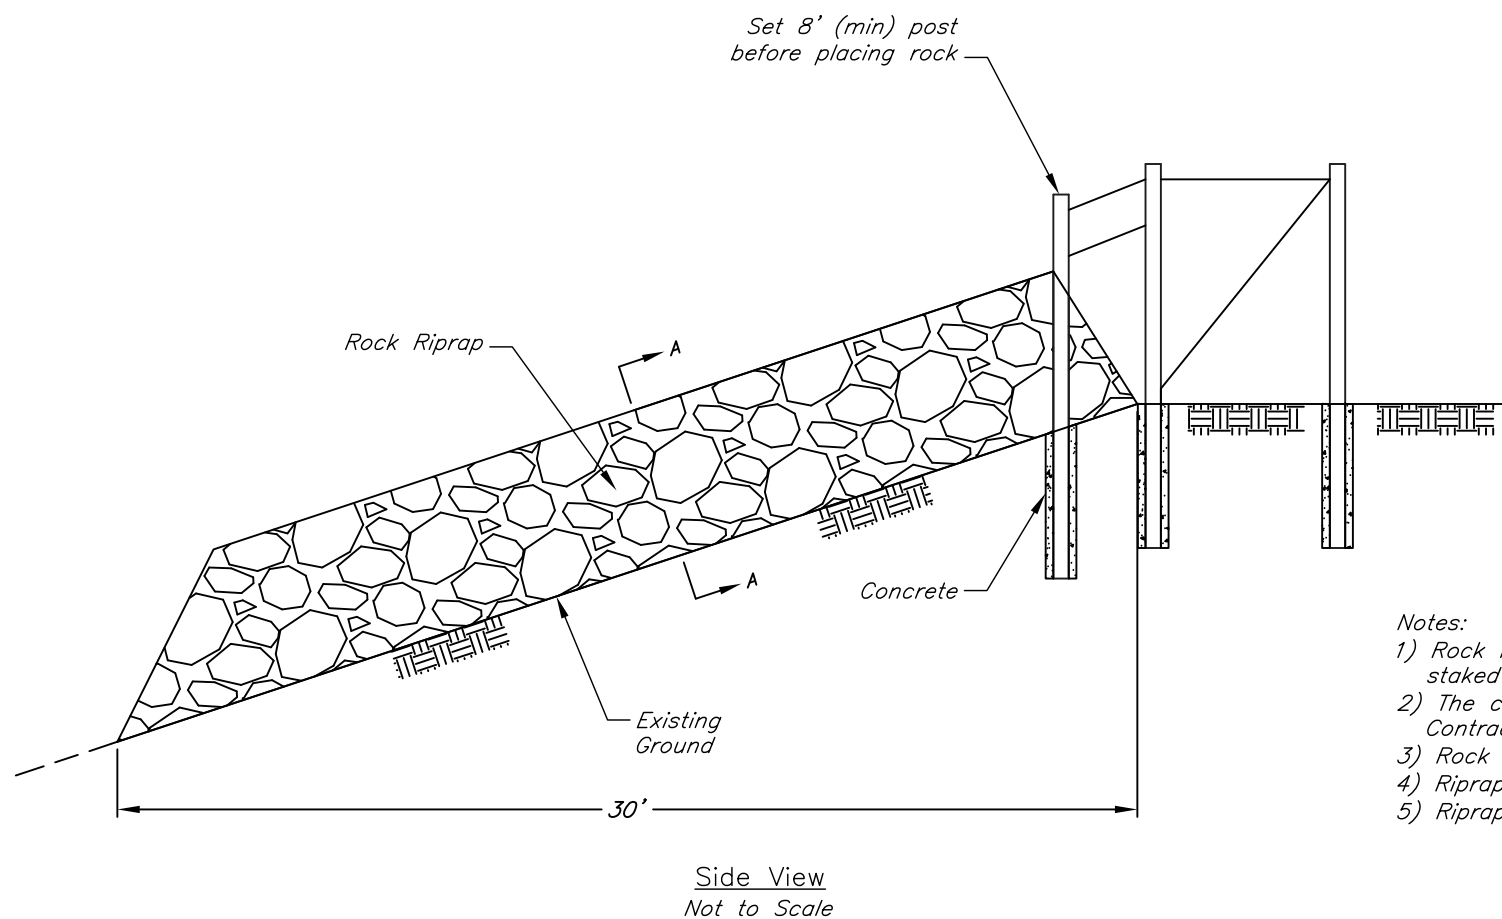
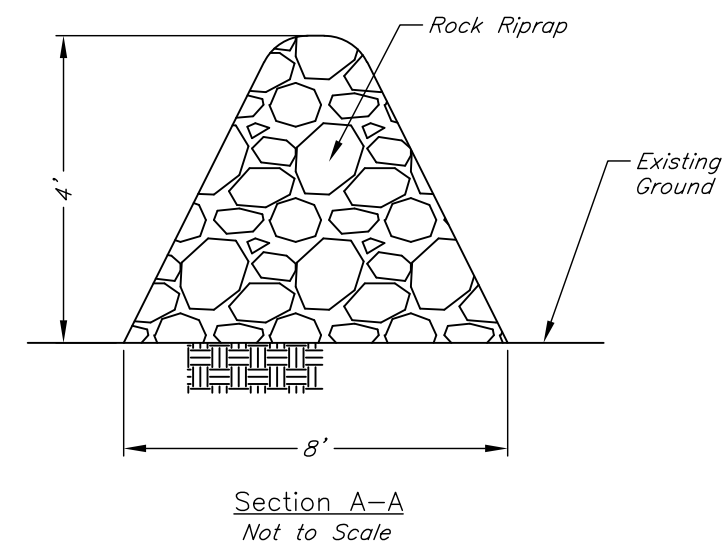
Fence Barrier Detail

- 1) Rock riprap shall be placed to form a fence barrier in the location specified on the plan sheets or staked in the field.
- 2) The construction staging area for equipment and rock stockpile shall be mutually determined by the Contractor and Project Engineer. A proposed location is shown on the plan sheets.
- 3) Rock riprap gradation shall meet KDOT Stone for Riprap Class - Light Series, Light 24' or Light 18"
- 4) Riprap quality shall meet KDOT Stone for Riprap - soundness and wear requirements.
- 5) Riprap source shall be approved by the Project Engineer.

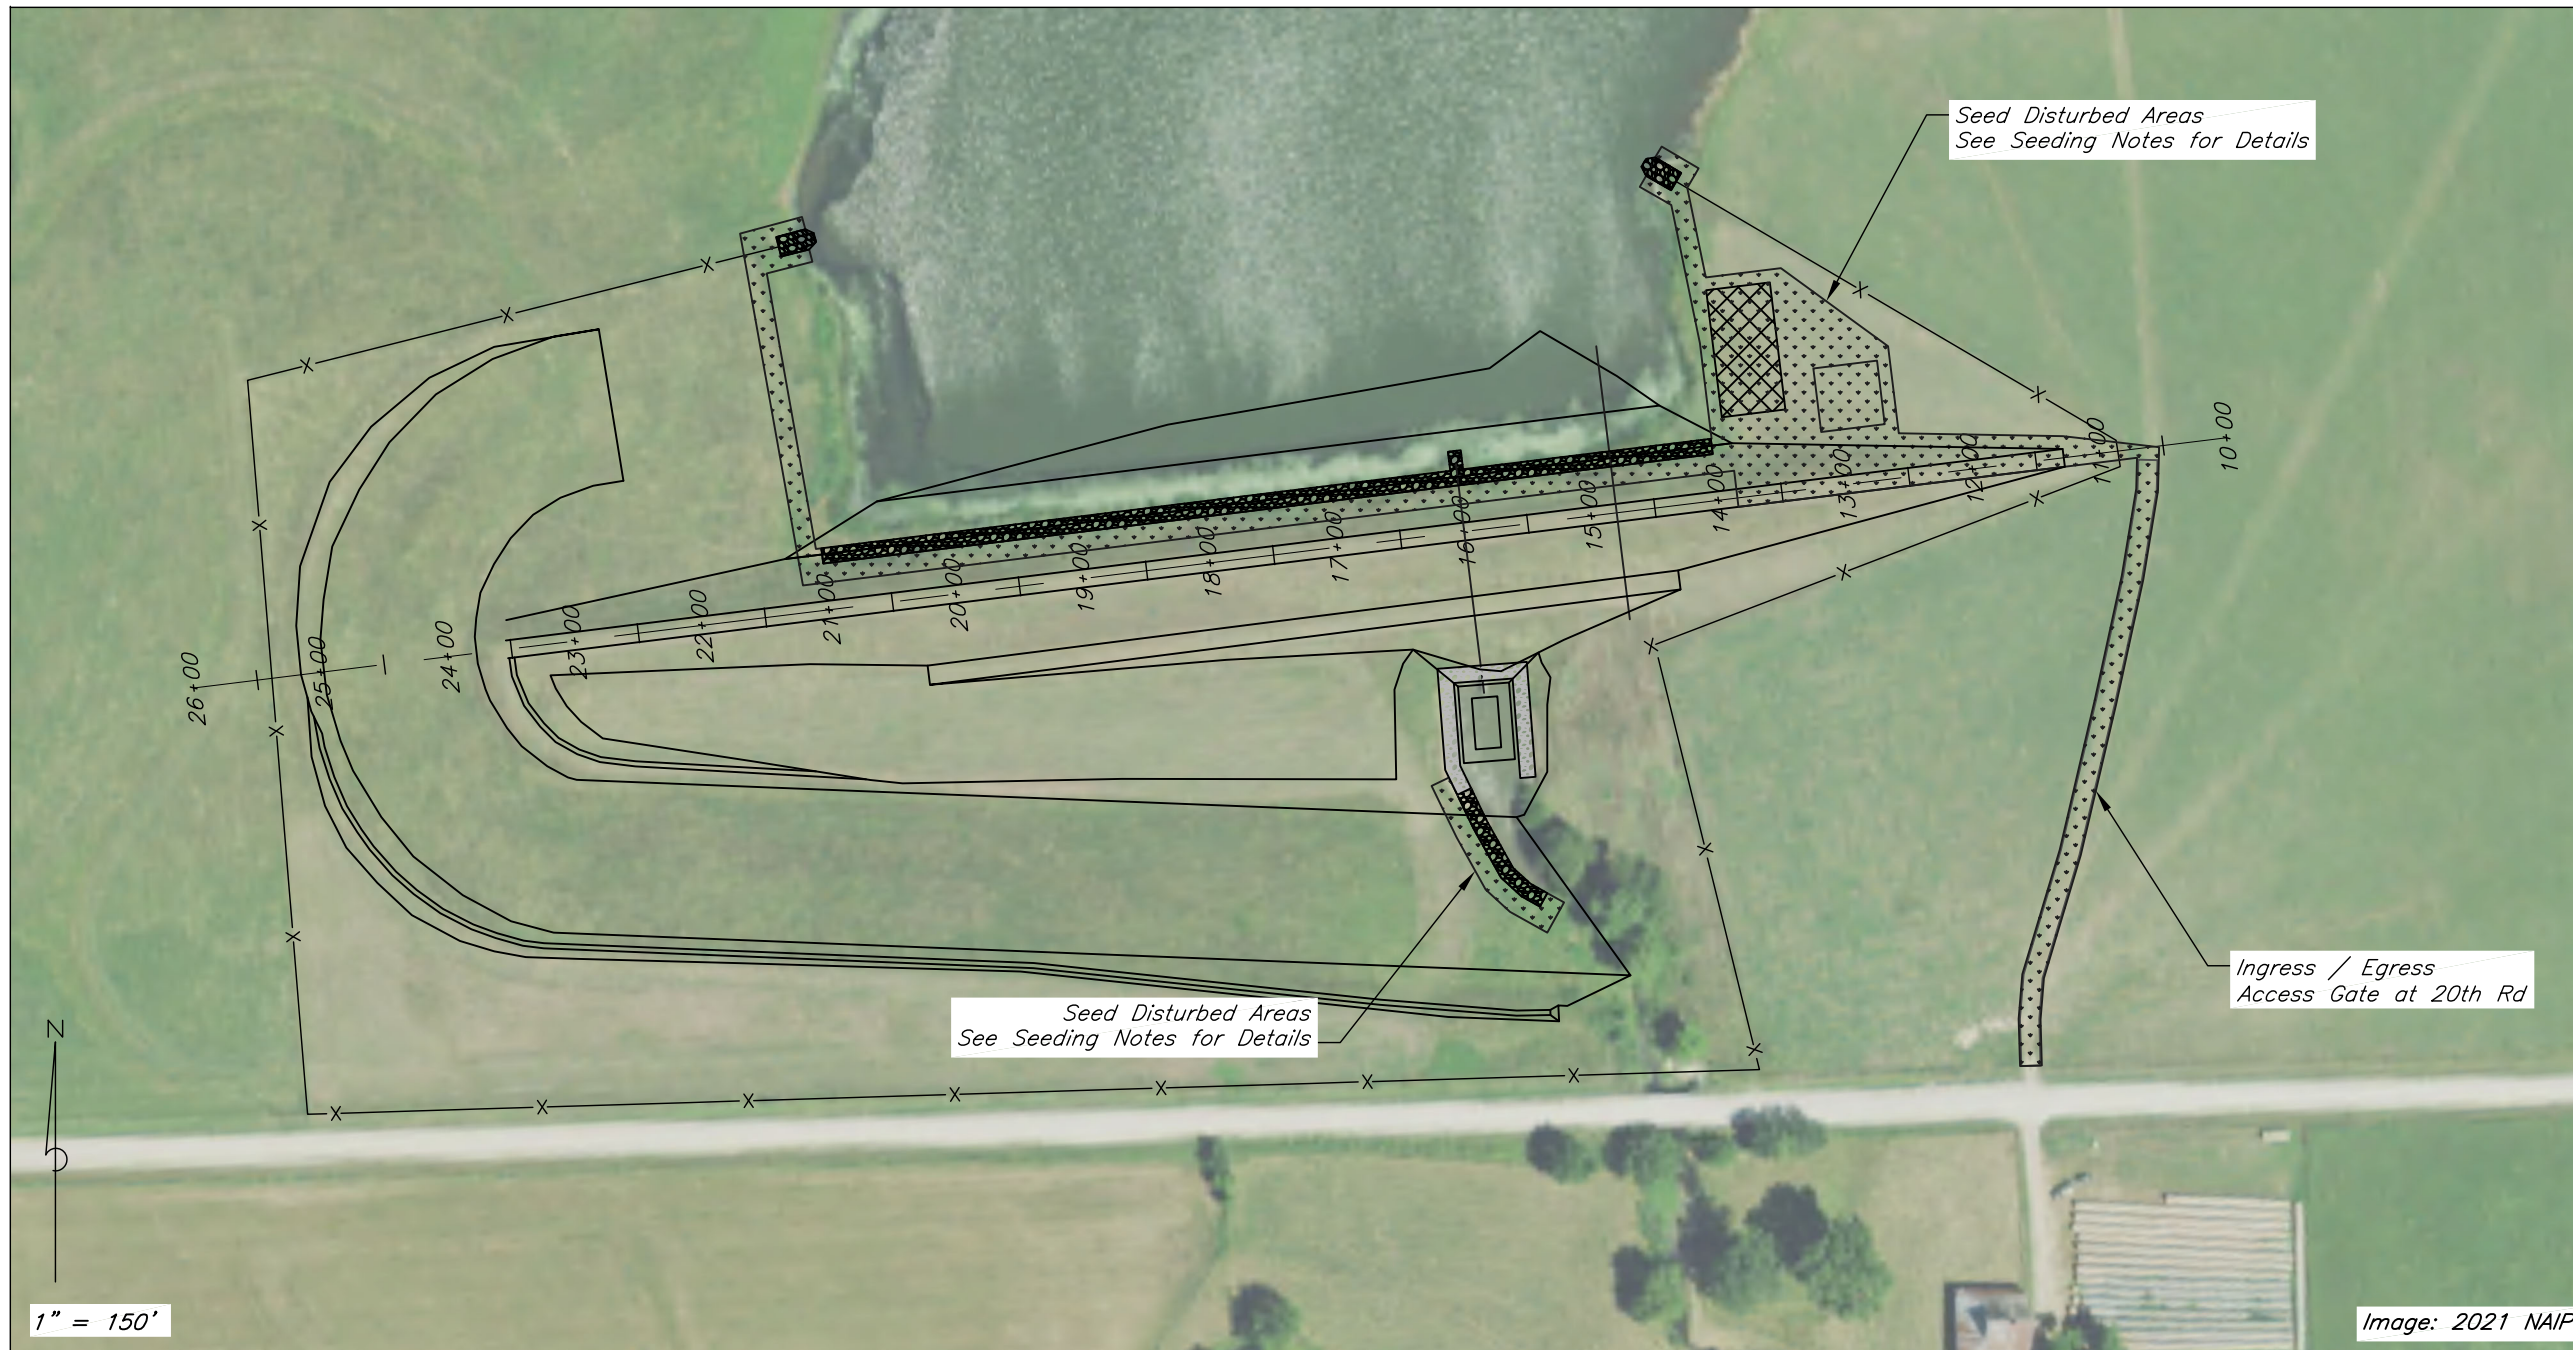
Pollution Control Notes:

- 1) The estimated total area of disturbance for this project is 1.5 acres. The primary area of disturbance will be in the front slope and outlet channel rehabilitation areas. Other areas of disturbance will occur in the ingress/egress route, equipment/material staging, and haul routes.

- 1) Reseed all areas disturbed during the dam rehabilitation as necessary (including ingress/egress route, equipment/material staging and haul routes)
- 2) Grass seed mix shall mimic that of the surrounding composition. A recommended mix shall be provided prior to planting.
